Inspection Report

Down To Earth Inspection

Date: 12/15/2018	Time: 08:00 AM	Report ID: A121418
Property:	Customer:	Real Estate Professional:

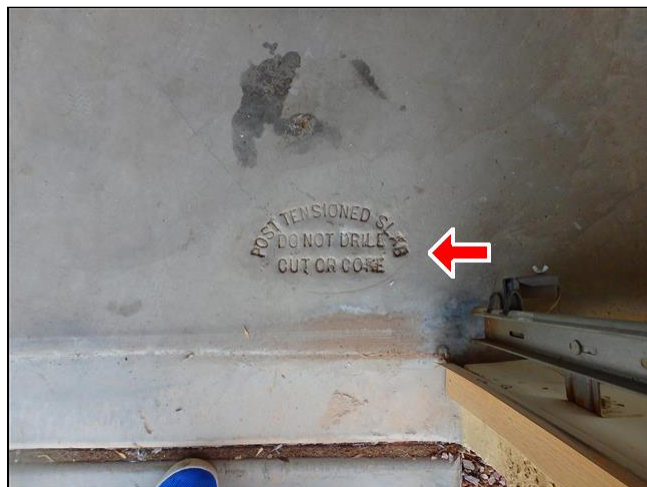
2.1 Item 1(Picture)

2.1 The foundation is a Post Tensioned Slab .This foundation type is superior to stem walls with floating floors or monolithic slabs and are common in areas known for soil movement. High tensioned cables are stretched tight within the concrete when curing and released to hold the slab from movement.Cutting and or drilling the slab is not advised unless structural evaluation is done prior to coring / drilling. See warning label stamped into the garage slab. No apparent problems were observed. However, Post Tension slabs will develop hairline and or small cracks just as a floating floor or monolithic slab will.

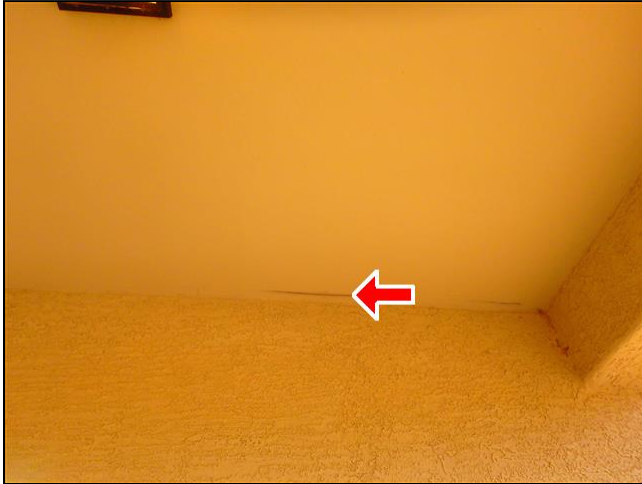
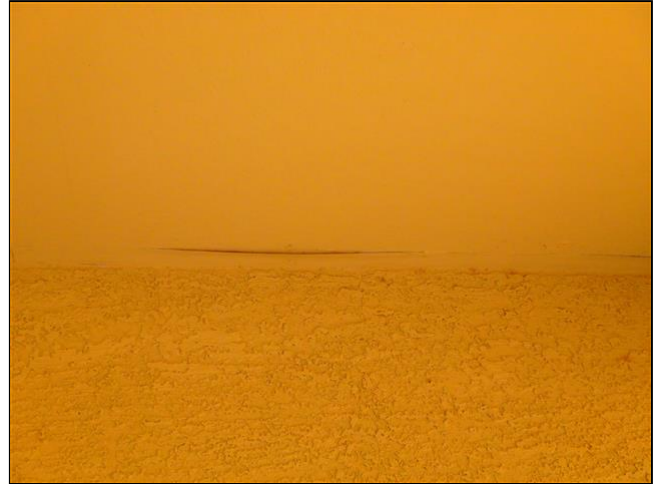
3.2 The exterior drywall ceiling located at the rear of the property has a bad tape joint. This is common in the state of Arizona and should be repaired and considered a maintenance item buy qualified technician.

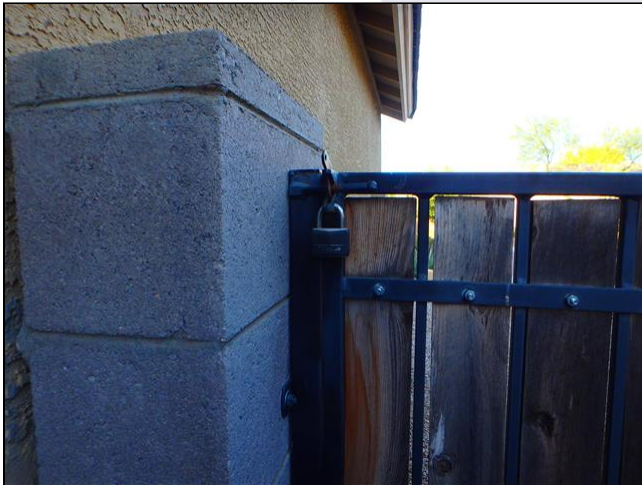
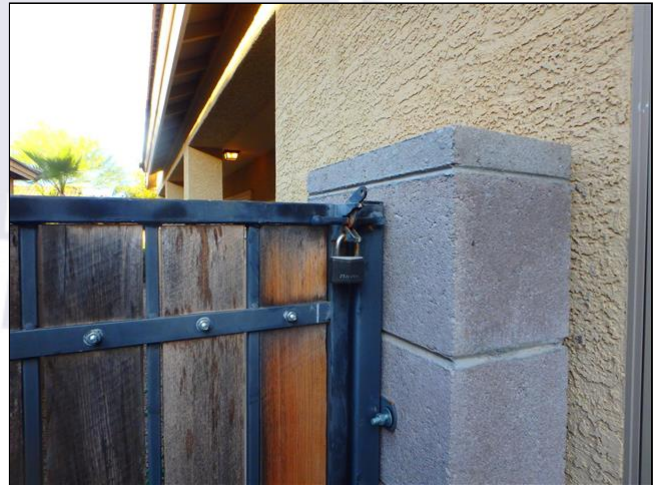
3.4 The gate at the north elevation and south elevation of the property was locked at the time of this inspection. We could not test the gate. If this gate provides direct access to a pool or spa, it should self close and latch to meet safety requirements. Recommend having the seller demonstrate operation of the gate.

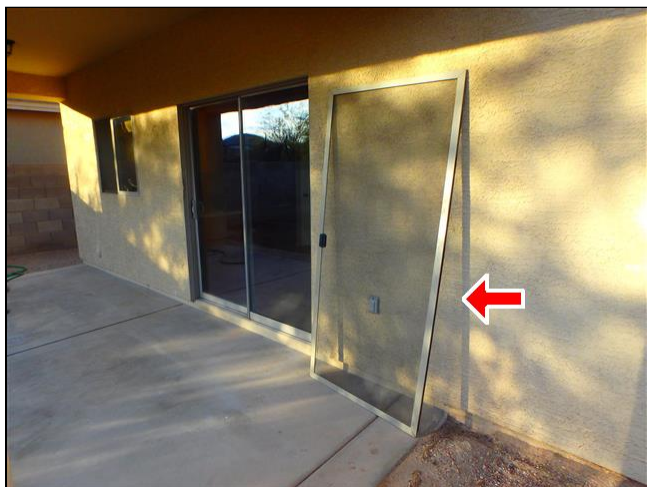
3.7 Item 1(Picture)

3.7 The screen door for the sliding glass door at the family room is off the track.

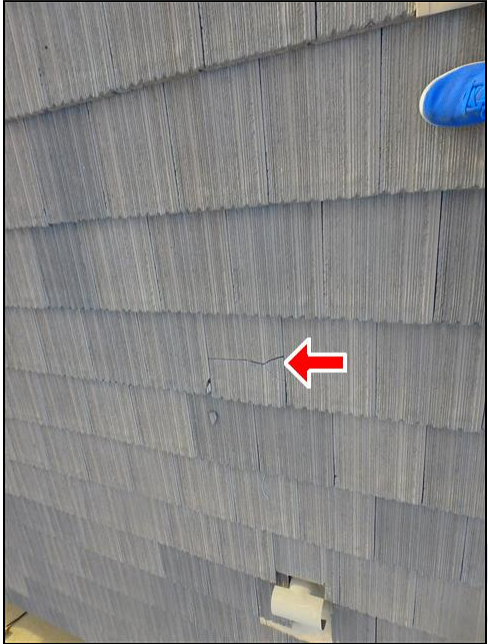
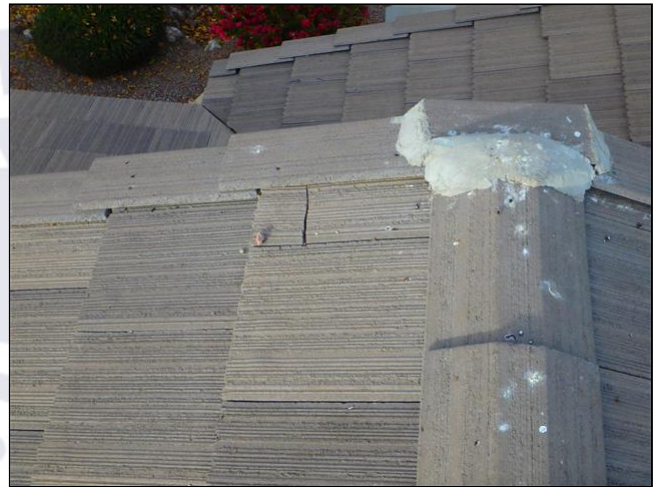
4.1 (1) There are broken tiles at various locations leaving the felt underlayment exposed. A qualified roofing contractor should review the roof covers and repair, replace tiles / underlayment as necessary.

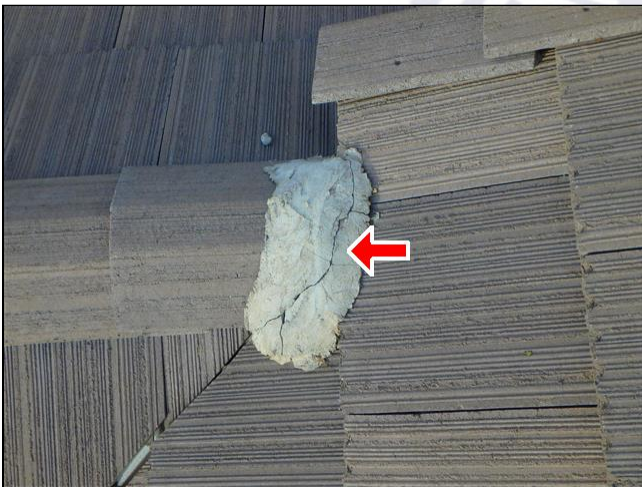
4.1 Item 9(Picture)

4.1 (2) The "wind breaks" installed to bond adjoining tile courses are cracked and or deteriorated at the west elevation. Wind breaks are masonry cement added at ridge, hip and eave terminations to protect tile from being blown off in high wind conditions.

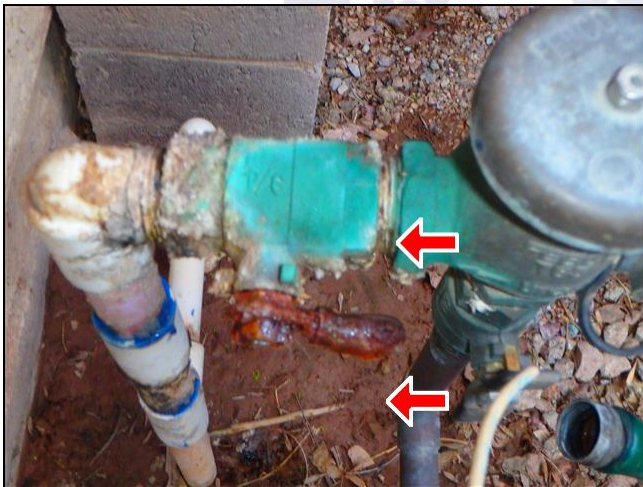
5.2 Item 1(Picture)

5.2 The photos show your shut off devices at the front of the house, and water meter. The meter was moving indicating that a leak in the supply lines is present. We recommend that you have a qualified plumber and or leak detection company review and repair as necessary.

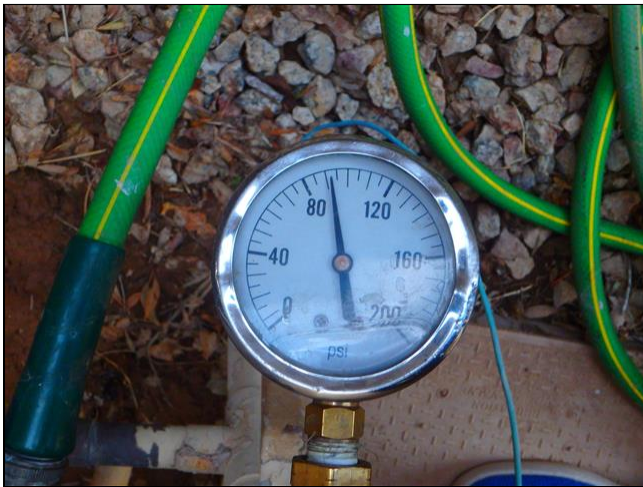
5.3 Item 1(Picture)

5.3 The water pressure, as measured by a gauge at an exterior hose bib, was at 80 PSI or above. 80 PSI is considered the pressure limit for residential plumbing. Excessive pressure can result in damage or failure to valves, seats, washers, and fixture supply lines. A qualified plumber should install an approved pressure regulator valve that will bring the pressure down to a normal PSI of 50 to 60.

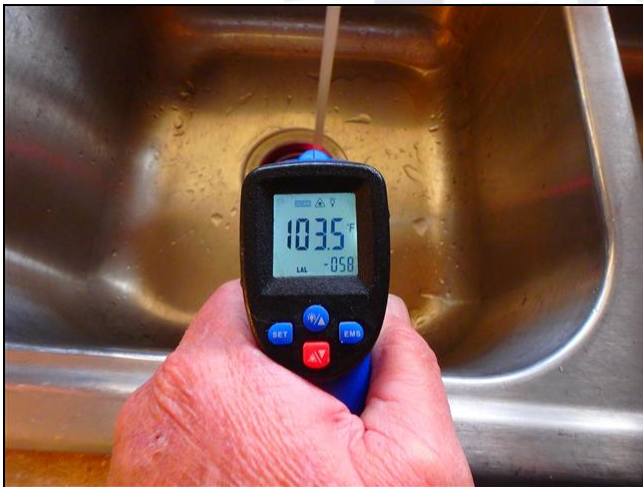
5.6 Item 1(Picture)

5.6 The design of electric water heaters does not lend itself to internal inspection. We cannot estimate its life expectancy. The water heater was intact and functional at time of inspection. NOTE: The normal useful life of most water heating systems is 8 to 10 years.

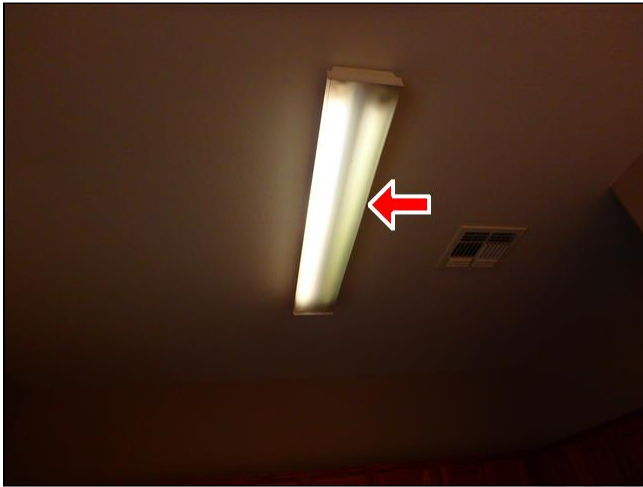
6.5 Item 1(Picture)

6.5 Light(s) in the kitchen is not functional. The bulb(s) may have burned out. Try replacing the bulb(s), and test the fixture. If a new bulb(s) does not correct the problem, a qualified electrician could make repairs or modifications as necessary.

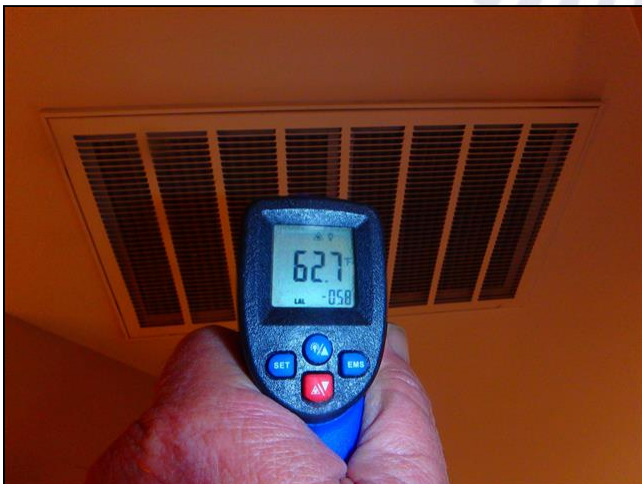
7.3 Item 1(Picture)

7.3 The heat pump(s) performed its intended function in the heating mode on the day of the inspection. The heat pump(s) cycled to and acceptable temperature of 95 degrees or above. NOTE: Due to seasonal restrictions for operation of heat pumps (see HEATING & COOLING INSPECTION LIMITATIONS), the reversing valve component allowing the system to operate in the COOLING mode could not be tested. While we regret this limitation, operation of heat pumps in the non seasonal mode could damage the compressor in the condensing unit.

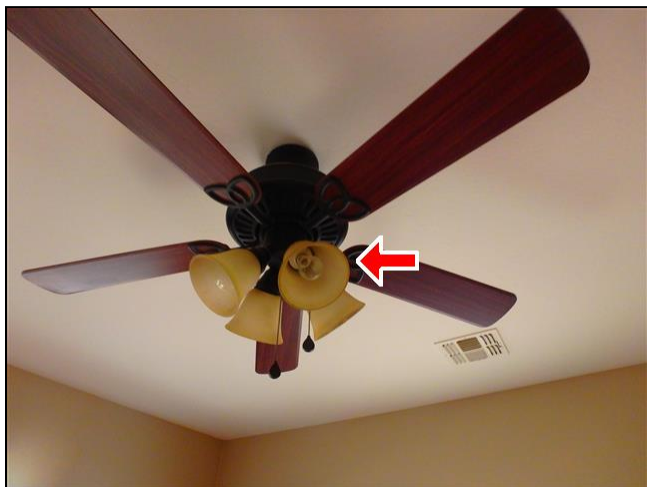
7.6 Item 1(Picture)

7.6 One or more of the ceiling fan light kits has one or more of the following conditions. Missing bulbs / missing globes / damage / broken inoperable pull chains.

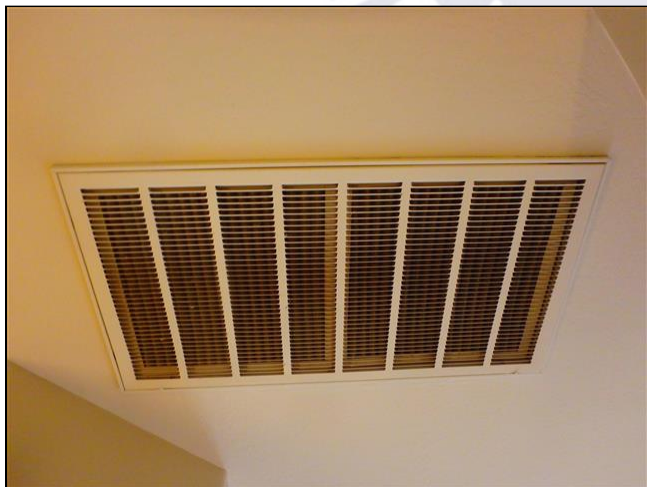
7.7 Item 1(Picture)

7.7 The filter is dirty. This decreases its effectiveness, and blocks airflow. This can dramatically decrease the efficiency of both the heating and cooling system if present. Change or wash the filters now, and at regular intervals thereafter. The filter should be replaced with a properly sized filter to ensure proper function. If the system has been operating in this condition for an extended period of time, service by a licensed HVAC contractor is advised to check the cleanliness of the fan, evaporator coil, ducts, etc., and clean it as needed.

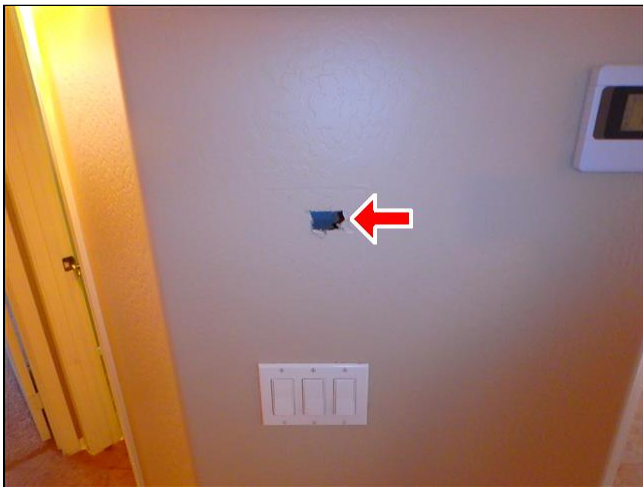
10.2 Item 1(Picture)

10.2 (2) There is a hole in the drywall in the main hallway. The hole should be repaired. A qualified technician can do the work.

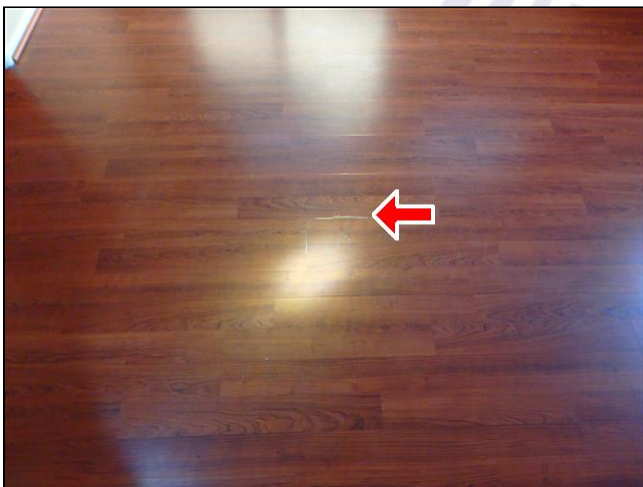
10.3 Item 1(Picture)

10.3 The laminated flooring in the master bedroom is lifting. After further inspection with a moisture meter from the termite company. It was showing on the day of the inspection 100% moisture. As there's typically no Plumbing in the master bedroom floor. In the Plumbing for the property runs through the ceiling this raises a concern. Recommend evaluation by a qualified technician.

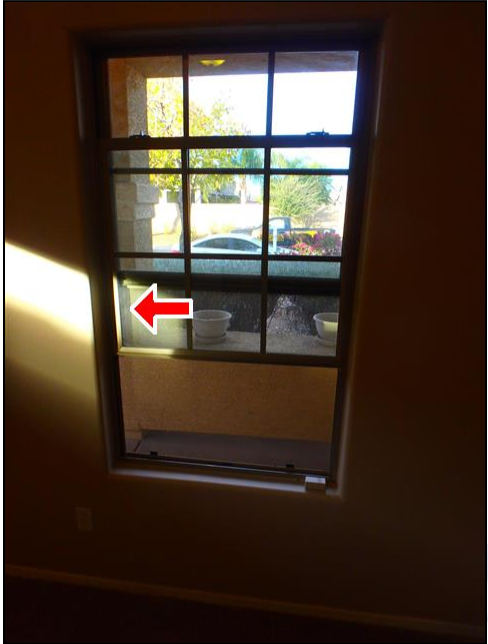
10.4 Item 1(Picture)

10.4 One or more of the windows in a hall bedroom does not operate properly. The counterweight spring mechanisms are damaged.

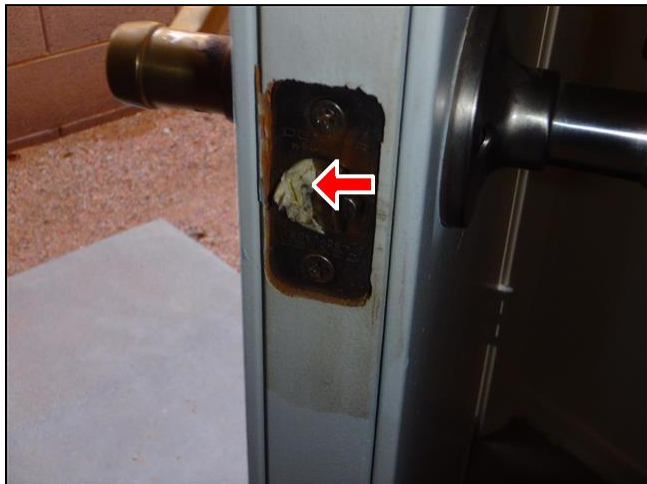
10.5 Item 1(Picture)

10.5 (1) Many of the door strikes in the property have tape enabling them from working. Recommend removing tape is necessary.

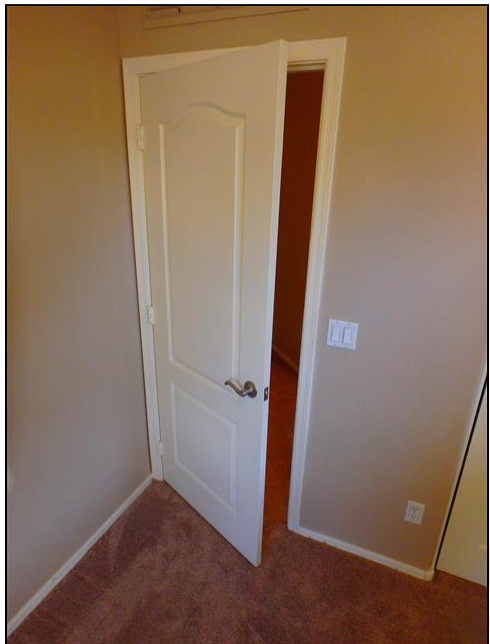
10.5 Item 5(Picture) Last bedroom

10.5 (2) A door at a hall bedroom binds on the jamb. This prevents easy operation of the door. Have a qualified technician adjust the door to restore proper operation.

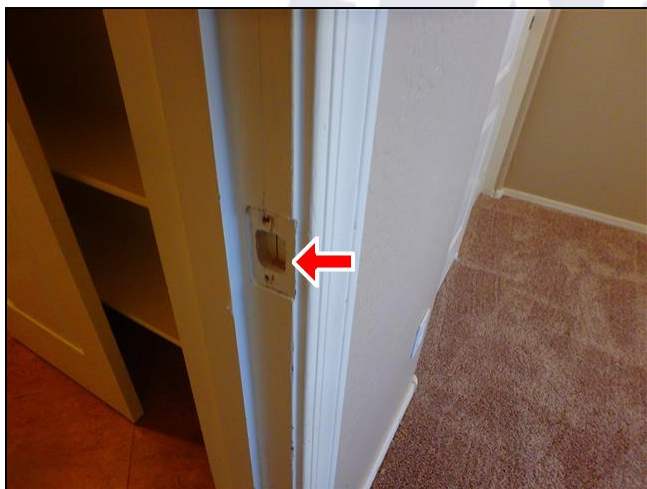
10.5 Item 6(Picture) Last bedroom

10.5 (3) Door hardware has been removed from a hall bedroom door(s). The door does not function properly. All loose or missing hardware can be repaired or replaced.

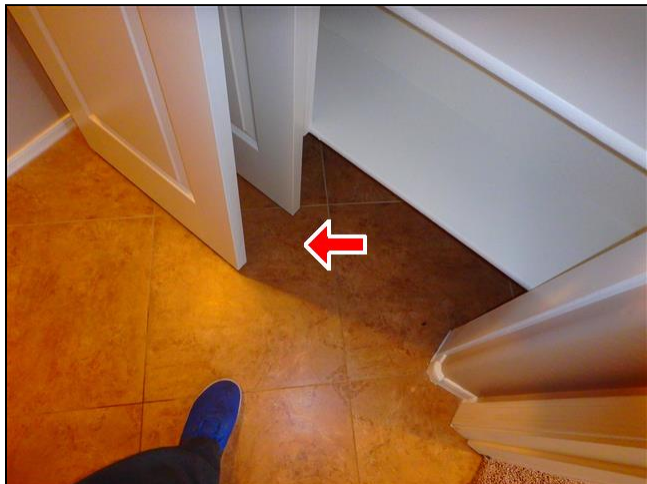
10.5 Item 7(Picture)

10.5 (4) The floor guides to the closet bypass door(s) in a hall closet is missing. The guides should be replaced/ installed.

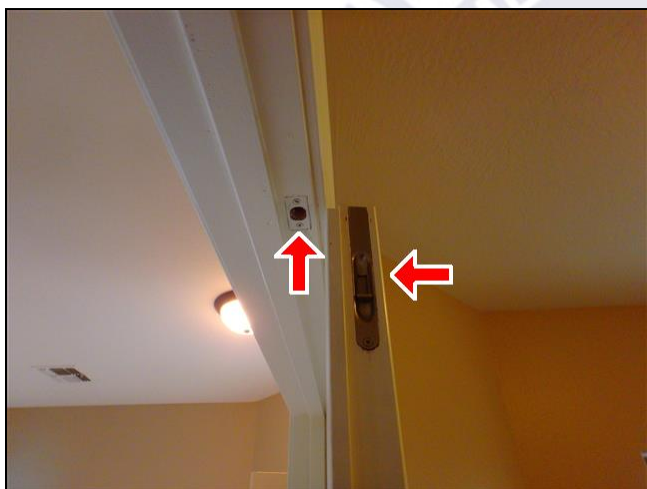
10.5 Item 8(Picture)

10.5 (5) The drop bolt in the office area is not functional. Recommend further review and repairs necessary by a qualified technician.

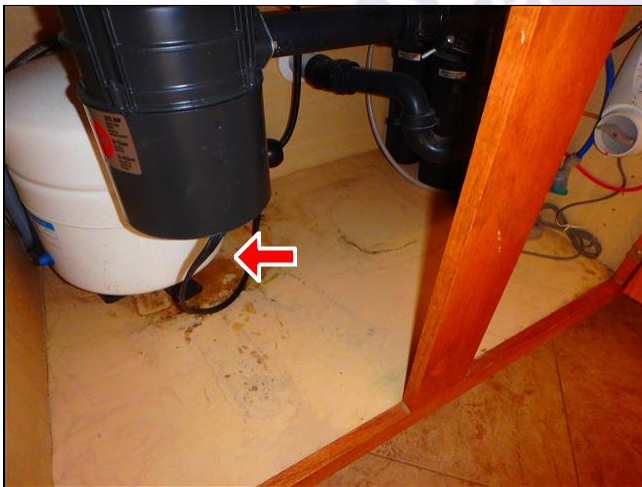
11.3 Item 1(Picture)

11.3 The Cabinet is deteriorated in the area under the sink. Water leakage appears to have promoted decay. Cracked, deteriorated or damaged wood should be replaced.

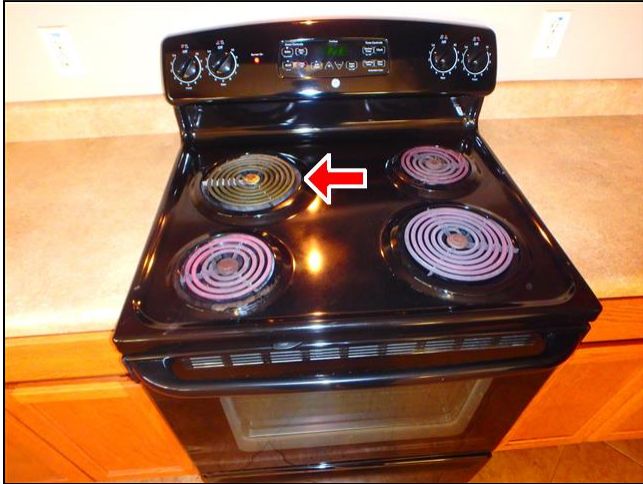
11.4 Item 1(Picture)

11.4 (1) The oven failed to respond to normal operating controls. A qualified appliance technician could make repairs or modifications as necessary.

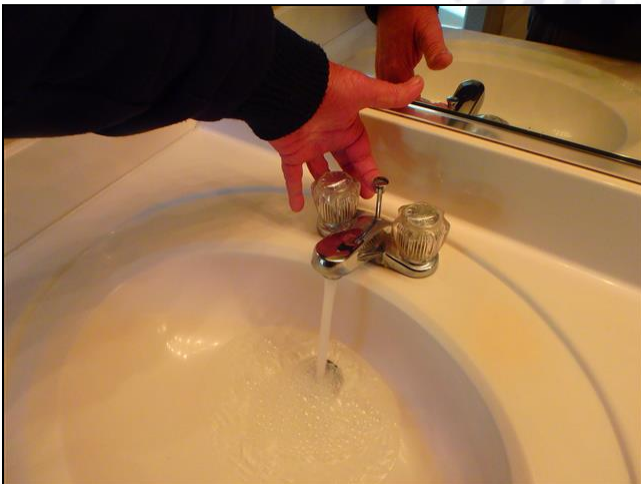
12.2 Item 4(Picture) Left side

12.2 (2) Drain stop(s) that were either missing or not functioning properly were found in the following locations: master bathroom. All drain stops should be functional.

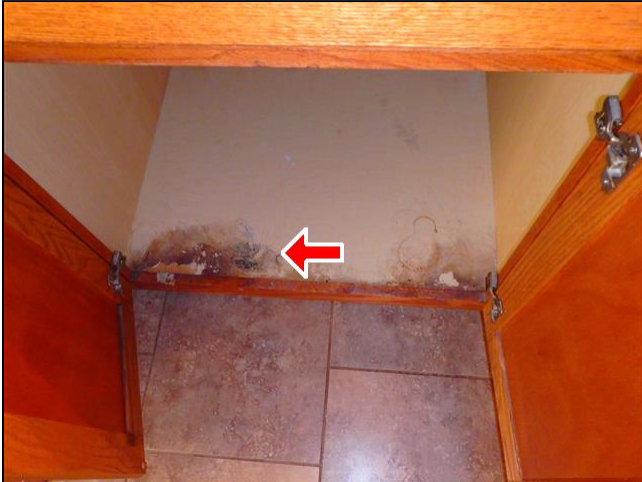
12.3 Item 1(Picture)

12.3 The floor of the cabinet in the master bathroom is water damaged. All damaged cabinet floors should be replaced with new materials, properly installed. No leaks observed at time of inspection.

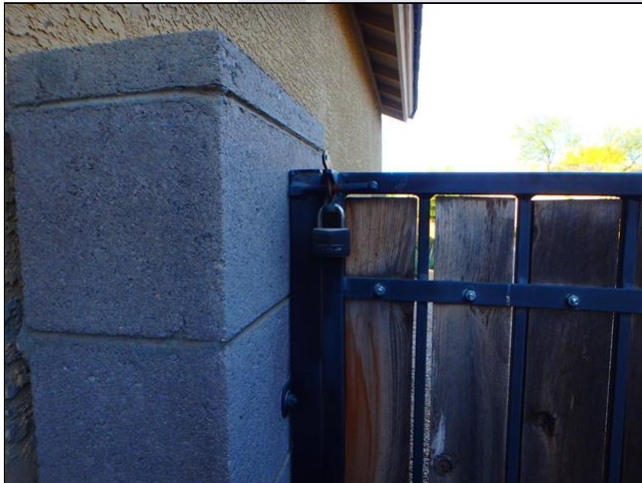
3.4 Item 1(Picture)

The gate at the north elevation and south elevation of the property was locked at the time of this inspection. We could not test the gate. If this gate provides direct access to a pool or spa, it should self close and latch to meet safety requirements. Recommend having the seller demonstrate operation of the gate.

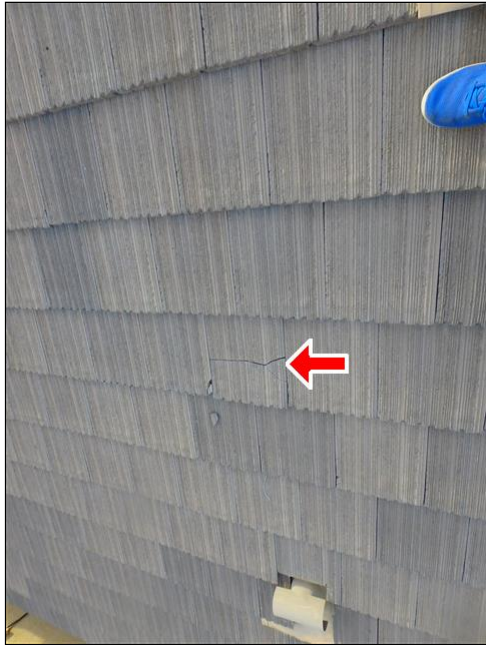
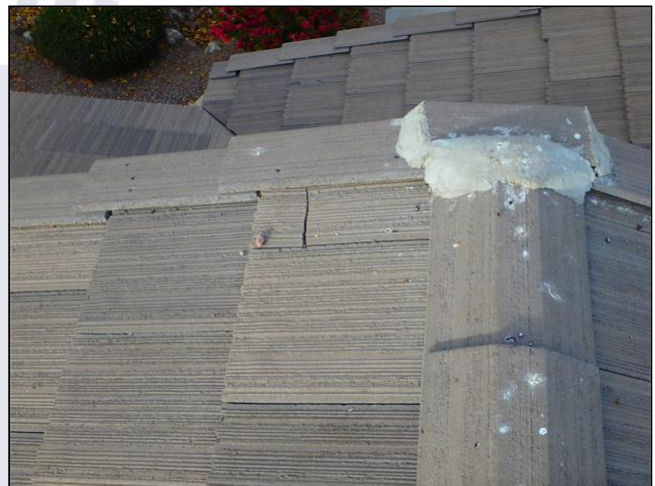
(1) There are broken tiles at various locations leaving the felt underlayment exposed. A qualified roofing contractor should review the roof covers and repair, replace tiles / underlayment as necessary.

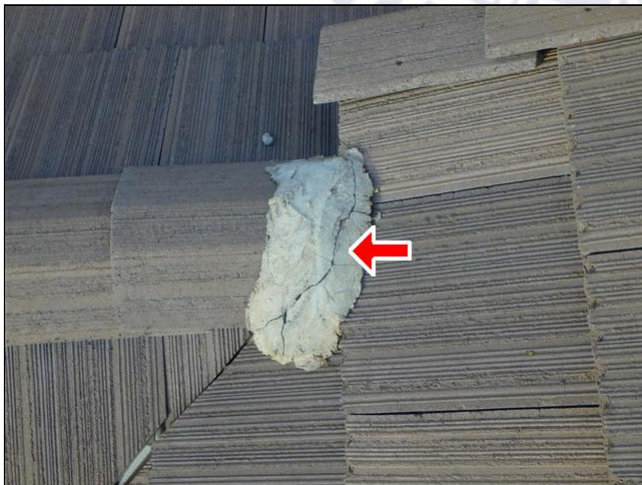
4.1 Item 9(Picture)

(2) The "wind breaks" installed to bond adjoining tile courses are cracked and or deteriorated at the west elevation. Wind breaks are masonry cement added at ridge, hip and eave terminations to protect tile from being blown off in high wind conditions.

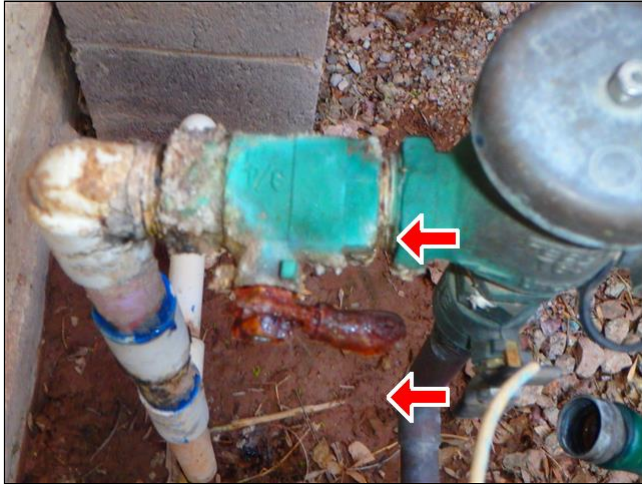
5.2 Item 1(Picture)

The photos show your shut off devices at the front of the house, and water meter. The meter was moving indicating that a leak in the supply lines is present. We recommend that you have a qualified plumber and or leak detection company review and repair as necessary.

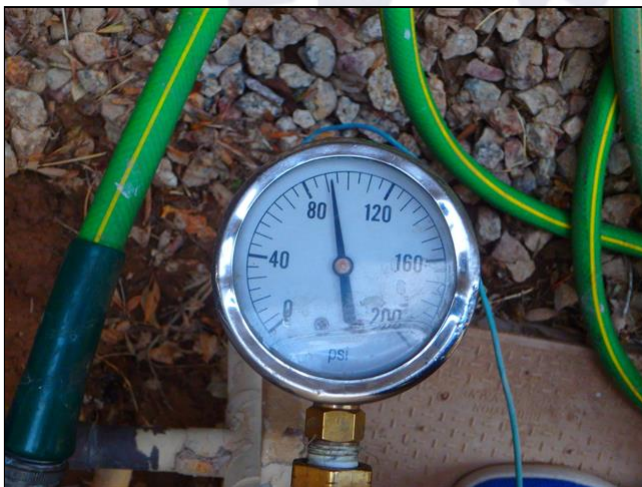
5.3 Item 1(Picture)

The water pressure, as measured by a gauge at an exterior hose bib, was at 80 PSI or above. 80 PSI is considered the pressure limit for residential plumbing. Excessive pressure can result in damage or failure to valves, seats, washers, and fixture supply lines. A qualified plumber should install an approved pressure regulator valve that will bring the pressure down to a normal PSI of 50 to 60.

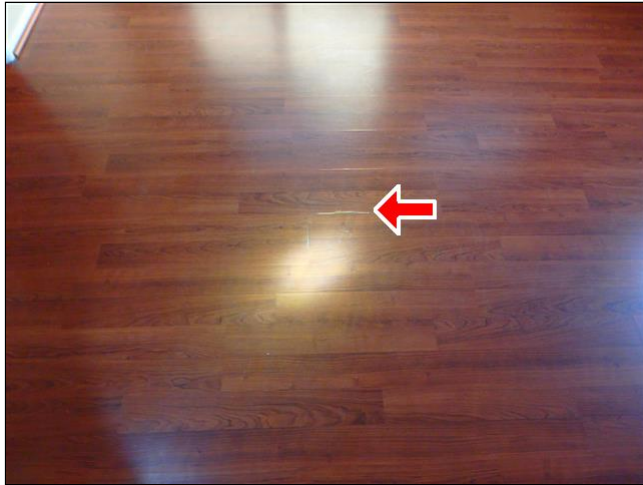
10.3 Item 1(Picture)

the master bedroom floor. In the Plumbing for the property runs through the ceiling this raises a concern. Recommend evaluation by a qualified technician.

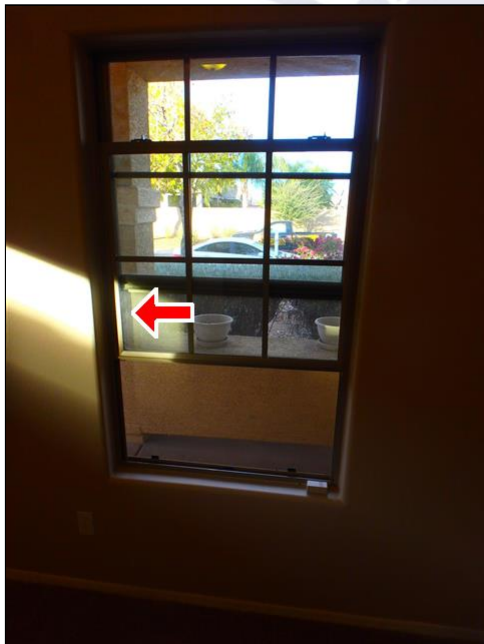
10.4 Item 1(Picture)

One or more of the windows in a hall bedroom does not operate properly. The counterweight spring mechanisms are damaged.

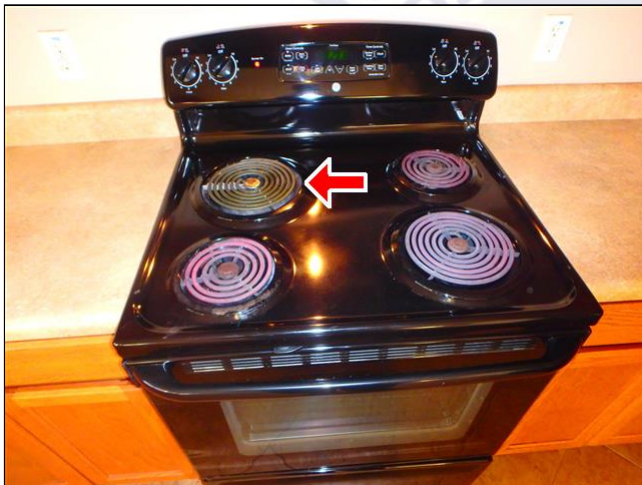
11.4 Item 1(Picture)

(1) The oven failed to respond to normal operating controls. A qualified appliance technician could make repairs or modifications as necessary.

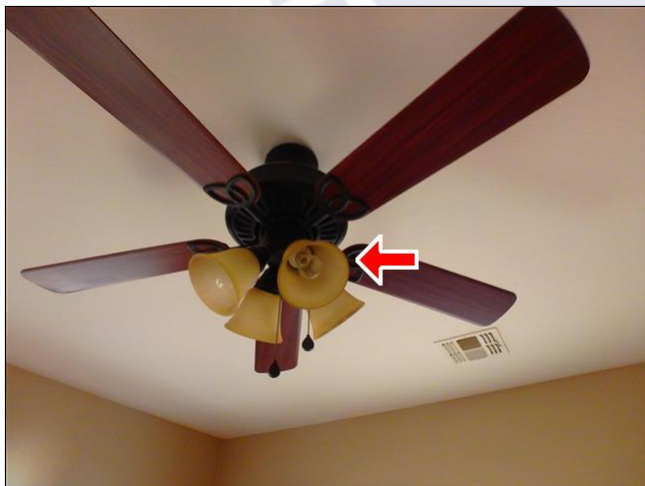
7.6 Item 1(Picture)

One or more of the ceiling fan light kits has one or more of the following conditions. Missing bulbs / missing globes / damage / broken inoperable pull chains.
