Inspection Report

Down To Earth Inspection

Summary

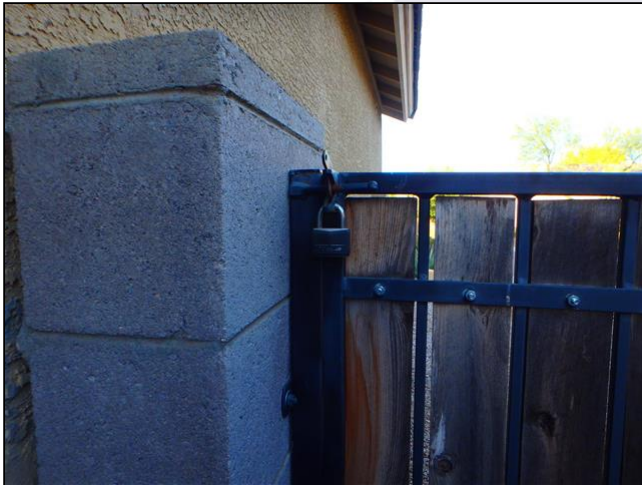
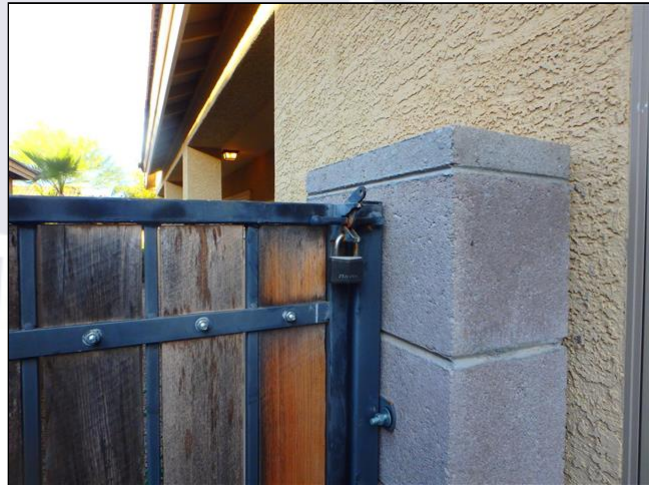
The gate at the north elevation and south elevation of the property was locked at the time of this inspection. We could not test the gate. If this gate provides direct access to a pool or spa, it should self close and latch to meet safety requirements. Recommend having the seller demonstrate operation of the gate.

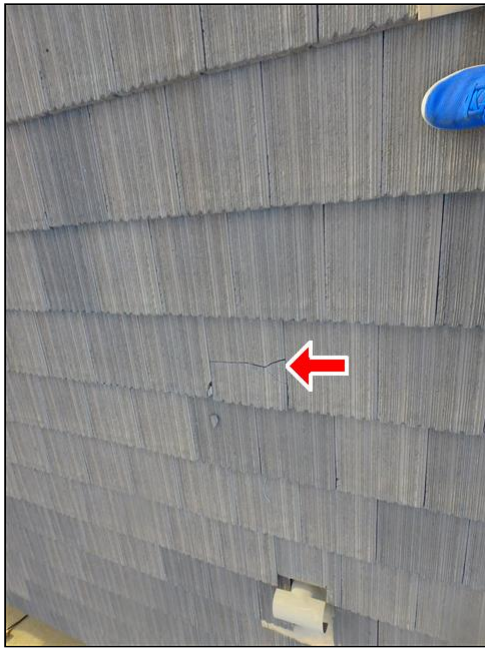
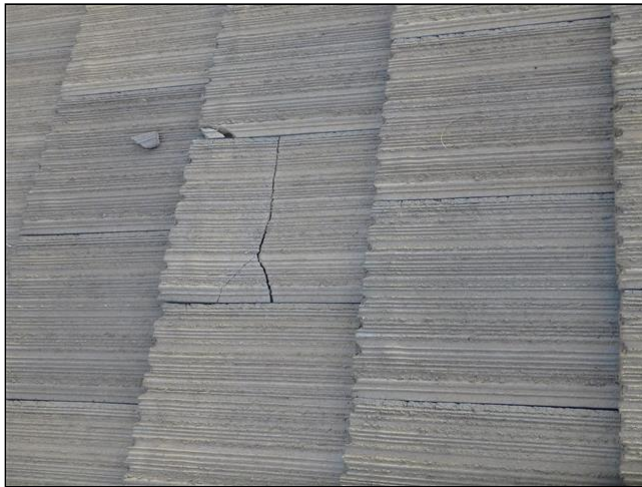
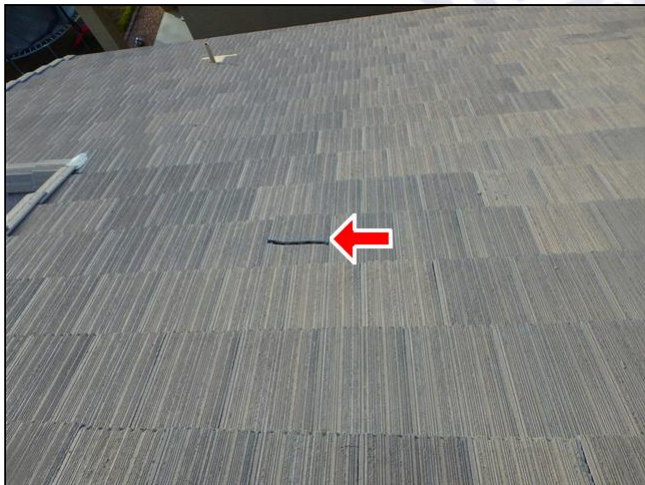
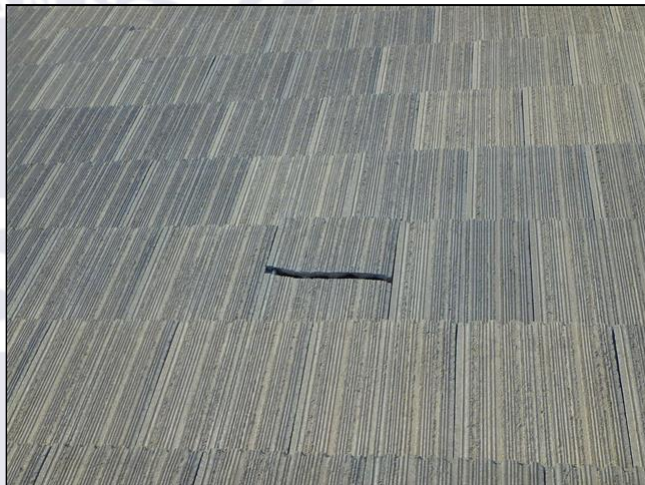
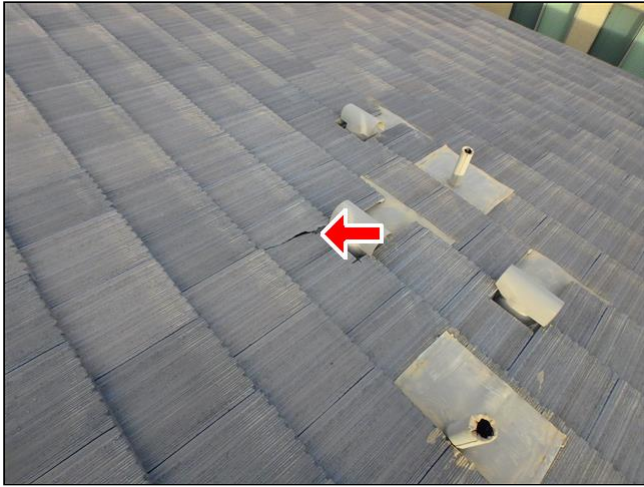
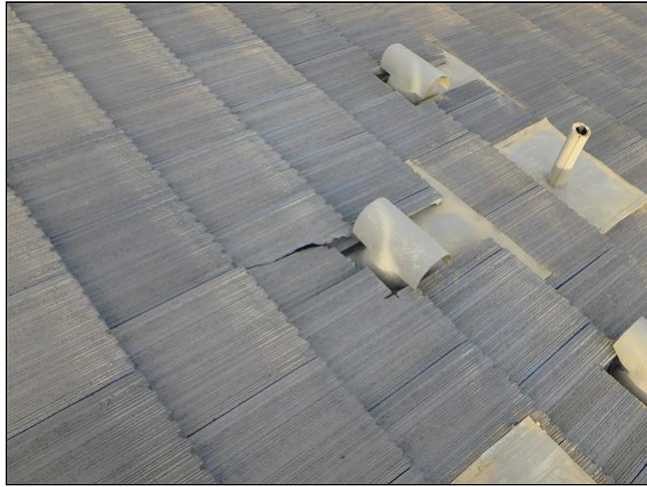
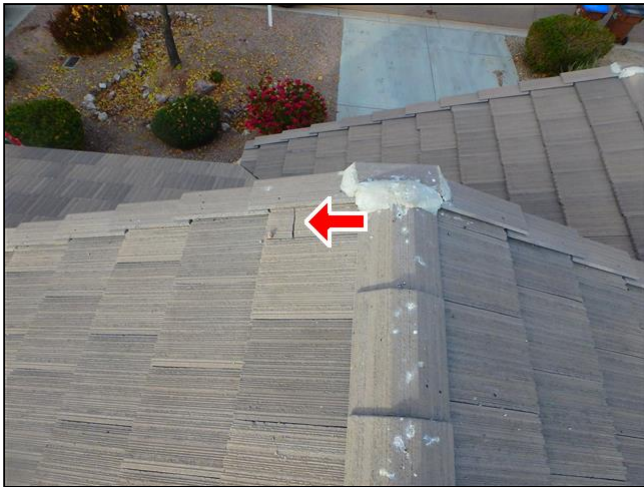
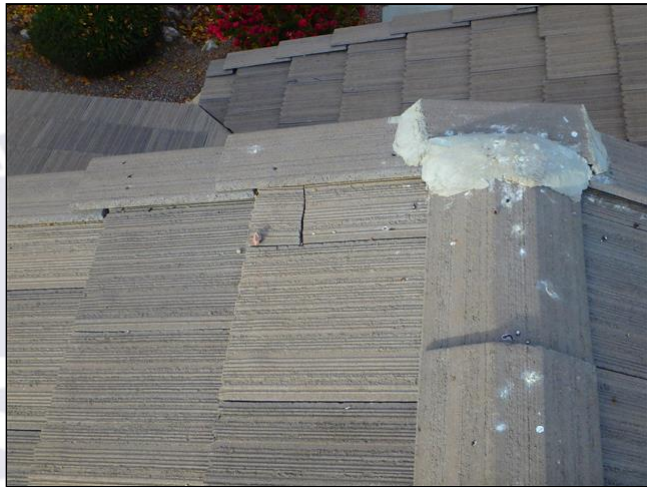
- (1) There are broken tiles at various locations leaving the felt underlayment exposed. A qualified roofing contractor should review the roof covers and repair, replace tiles / underlayment as necessary.

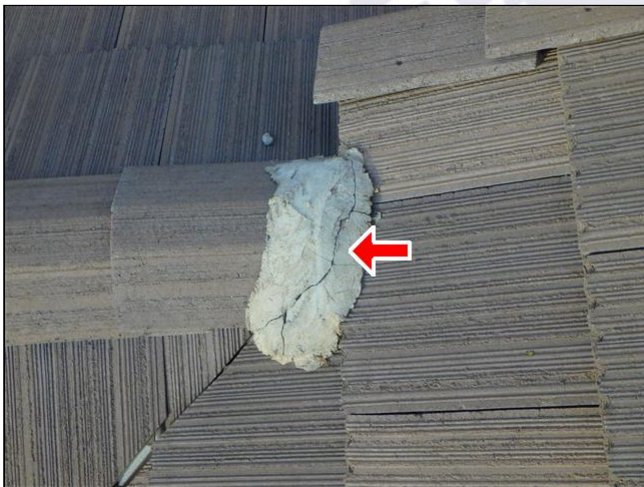
Item 3 - Item 1(Picture)

(2) The "wind breaks" installed to bond adjoining tile courses are cracked and or deteriorated at the west elevation. Wind breaks are masonry cement added at ridge, hip and eave terminations to protect tile from being blown off in high wind conditions.

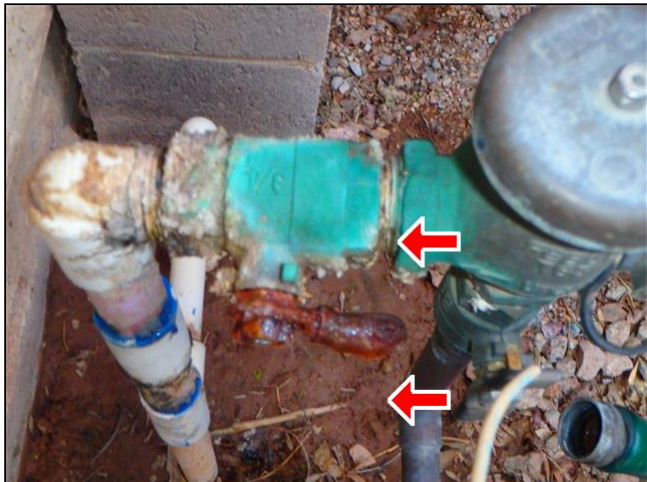
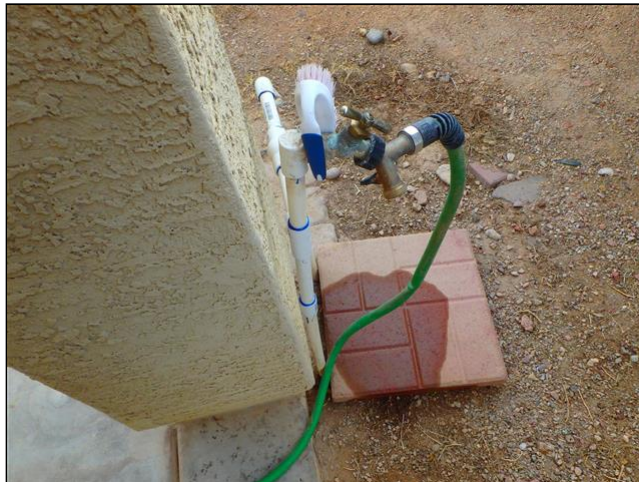
The photos show your shut off devices at the front of the house, and water meter. The meter was moving indicating that a leak in the supply lines is present. We recommend that you have a qualified plumber and or leak detection company review and repair as necessary.

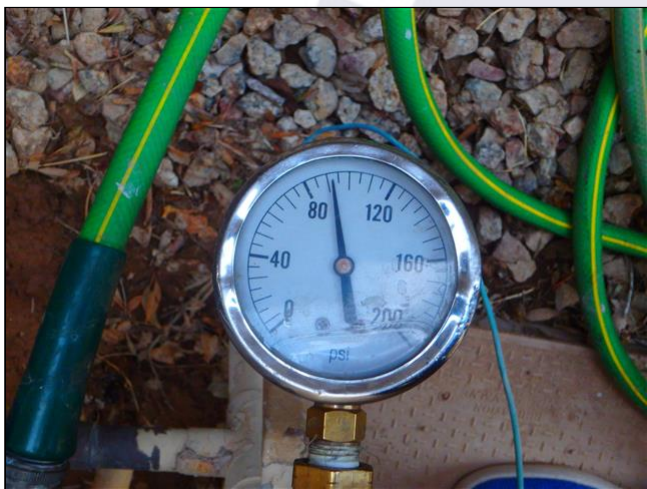
Item 5 - Item 1(Picture)

The water pressure, as measured by a gauge at an exterior hose bib, was at 80 PSI or above. 80 PSI is considered the pressure limit for residential plumbing. Excessive pressure can result in damage or failure to valves, seats, washers, and fixture supply lines. A qualified plumber should install an approved pressure regulator valve that will bring the pressure down to a normal PSI of 50 to 60.

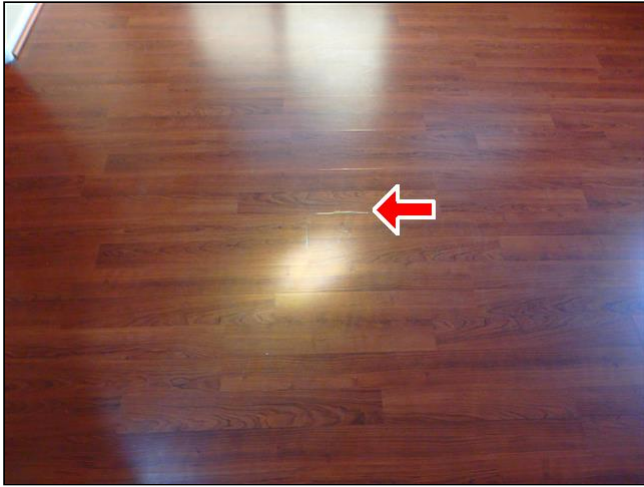
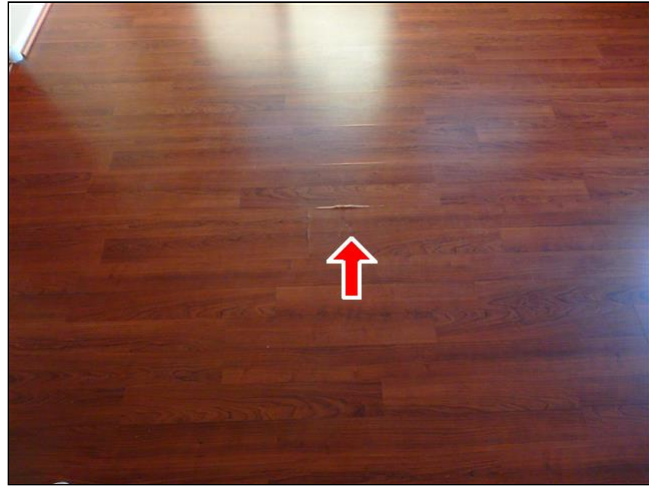
6. The laminated flooring in the master bedroom is lifting. After further inspection with a moisture meter from the termite company. It was showing on the day of the inspection 100% moisture. As there's typically no Plumbing in the master bedroom floor. In the Plumbing for the property runs through the ceiling this raises a concern. Recommend evaluation by a qualified technician.

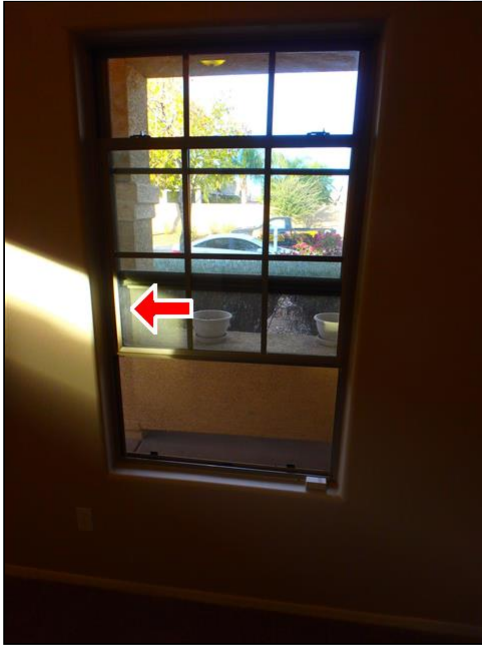
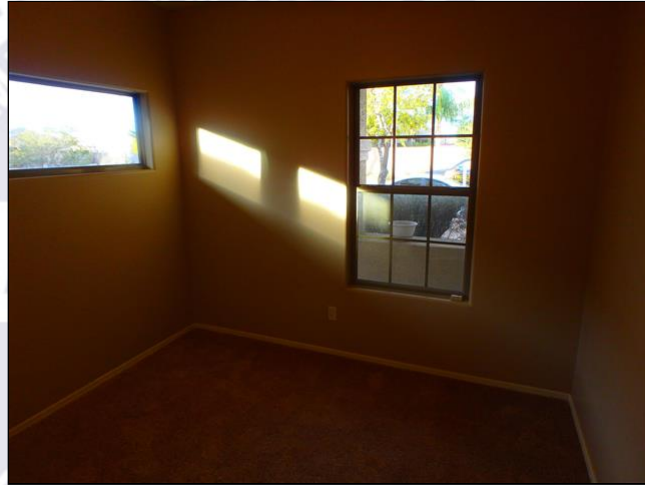
One or more of the windows in a hall bedroom does not operate properly. The counterweight spring mechanisms are damaged.

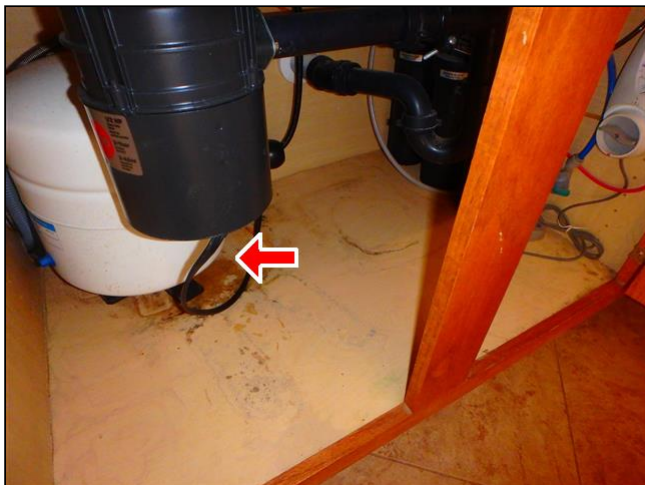
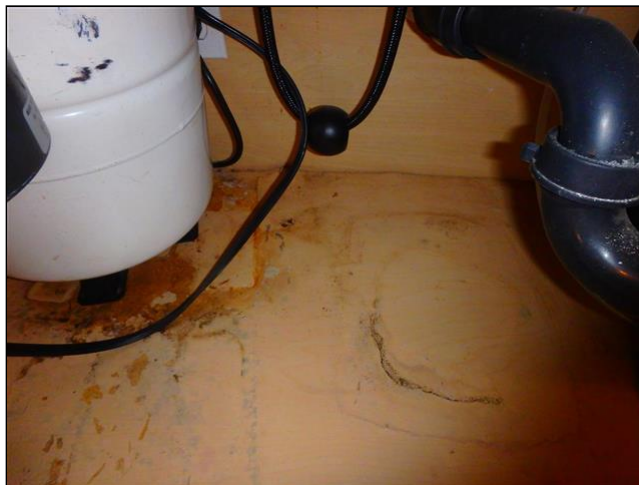
8. The Cabinet is deteriorated in the area under the sink. Water leakage appears to have promoted decay. Cracked, deteriorated or damaged wood should be replaced.

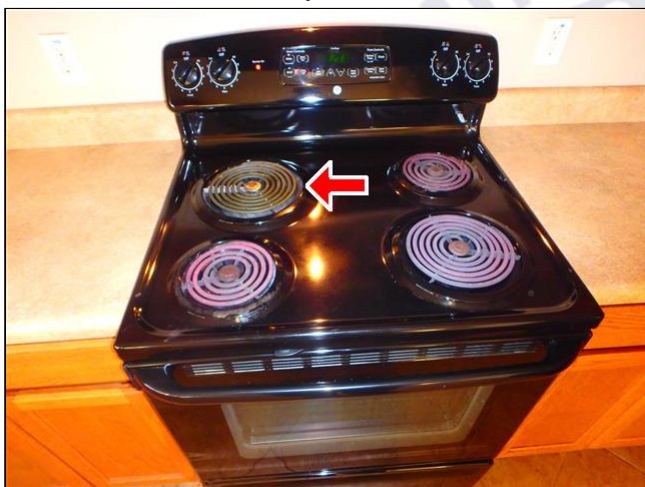
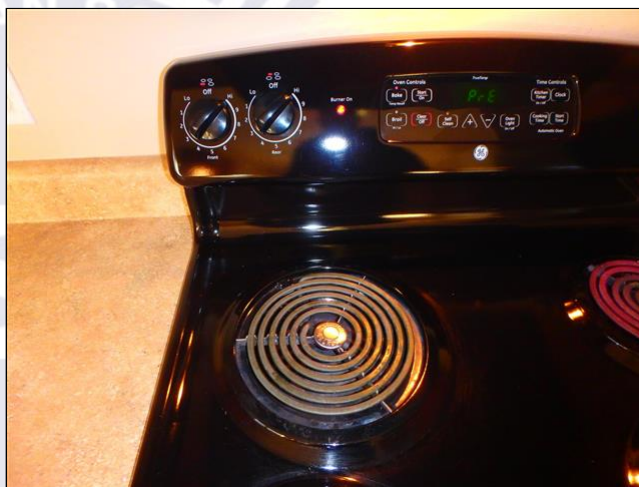
(1) The oven failed to respond to normal operating controls. A qualified appliance technician could make repairs or modifications as necessary.

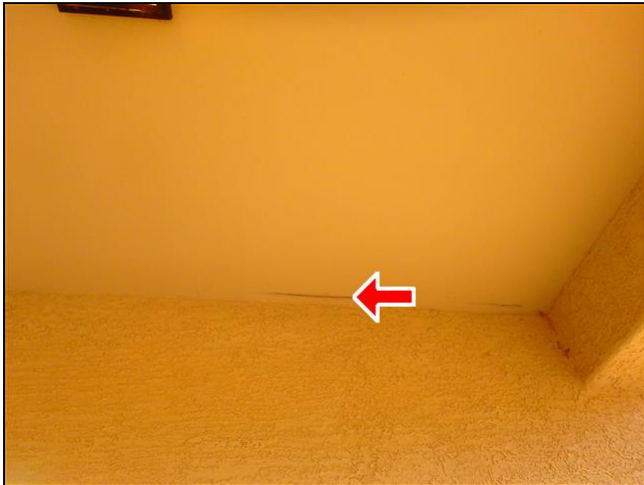
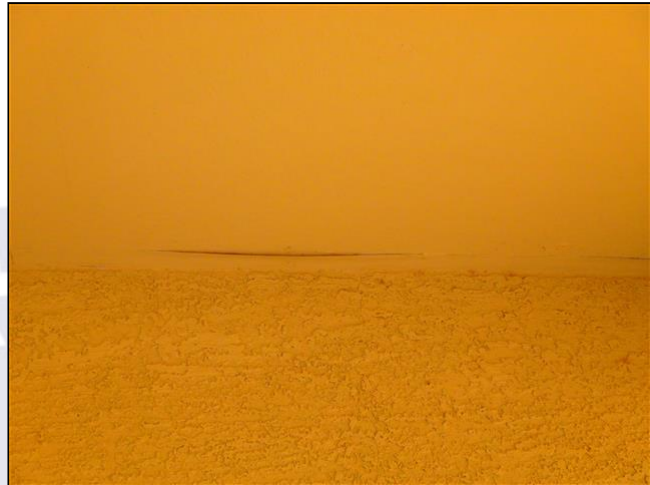
The exterior drywall ceiling located at the rear of the property has a bad tape joint. This is common in the state of Arizona and should be repaired and considered a maintenance item buy qualified technician.

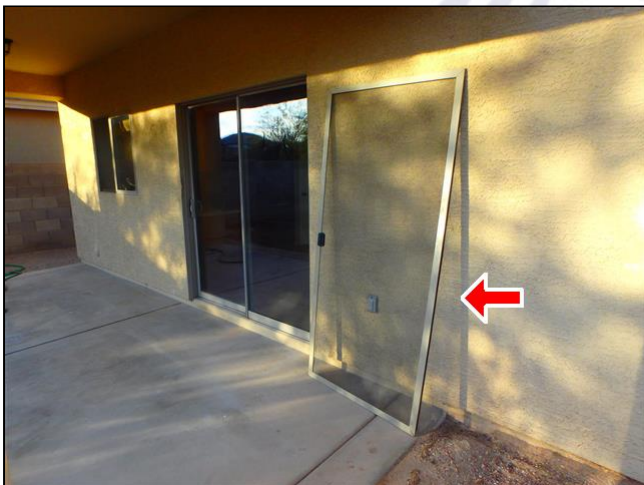
Item 15 - Item 1(Picture)

The screen door for the sliding glass door at the family room is off the track.

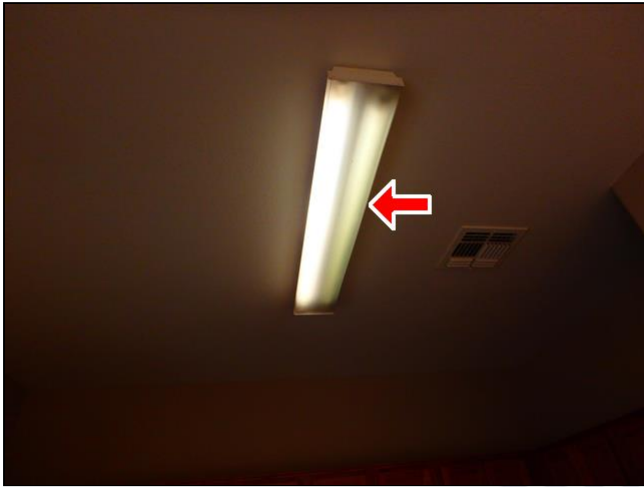
Item 16 - Item 1(Picture)

Light(s) in the kitchen is not functional. The bulb(s) may have burned out. Try replacing the bulb(s), and test the fixture. If a new bulb(s) does not correct the problem, a qualified electrician could make repairs or modifications as necessary.

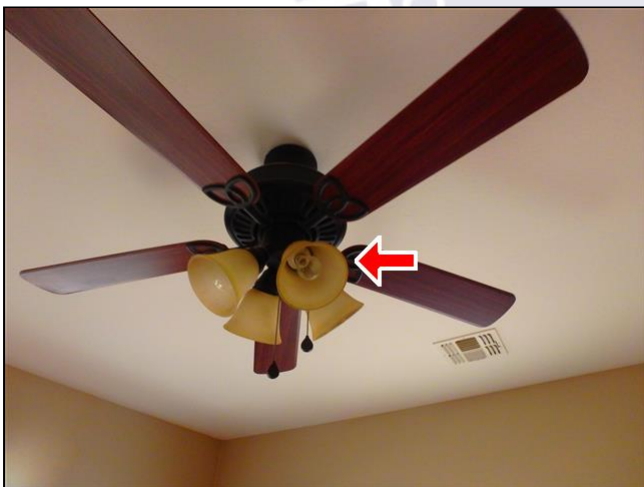
Item 18 - Item 1(Picture)

One or more of the ceiling fan light kits has one or more of the following conditions. Missing bulbs / missing globes / damage / broken inoperable pull chains.

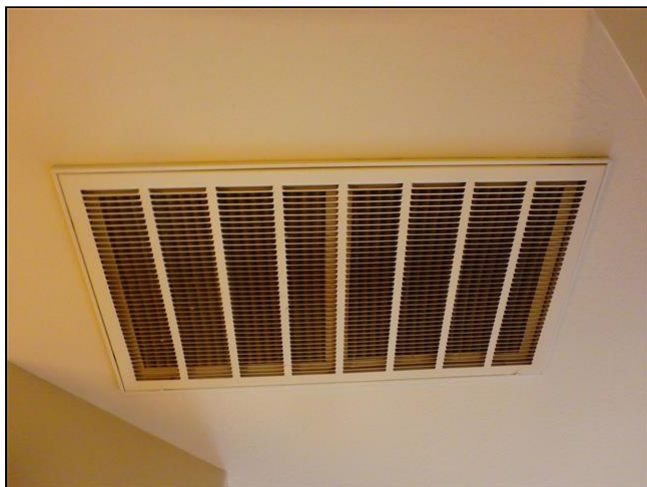
Item 19 - Item 1(Picture)

The filter is dirty. This decreases its effectiveness, and blocks airflow. This can dramatically decrease the efficiency of both the heating and cooling system if present.

Change or wash the filters now, and at regular intervals thereafter. The filter should be replaced with a properly sized filter to ensure proper function. If the system has been operating in this condition for an extended period of time, service

by a licensed HVAC contractor is advised to check the cleanliness of the fan, evaporator coil, ducts, etc., and clean it as needed.

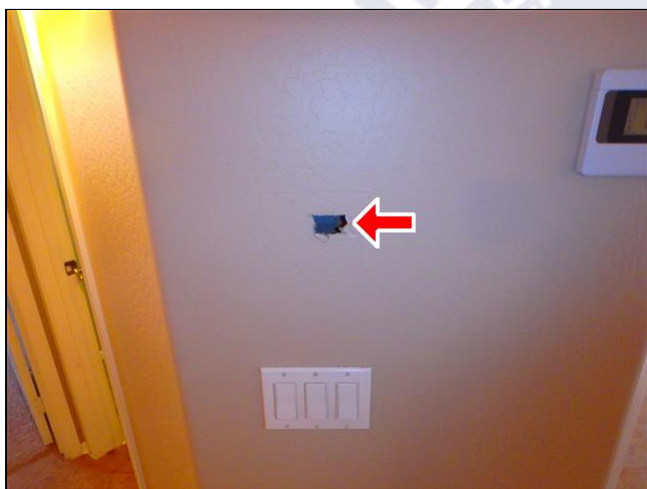
Item 20 - Item 1(Picture)

(2) There is a hole in the drywall in the main hallway. The hole should be repaired. A qualified technician can do the work.

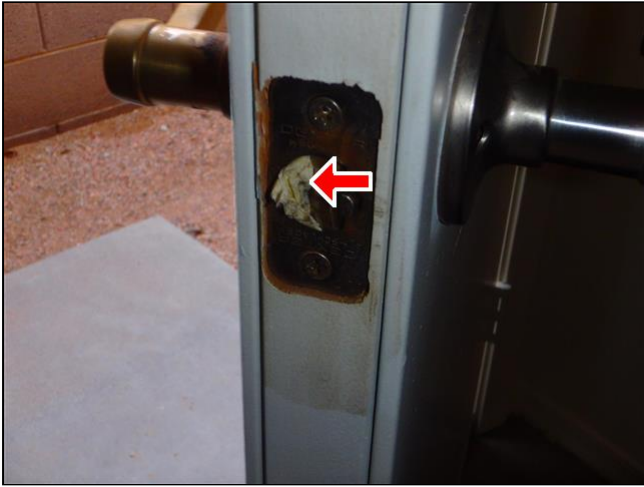
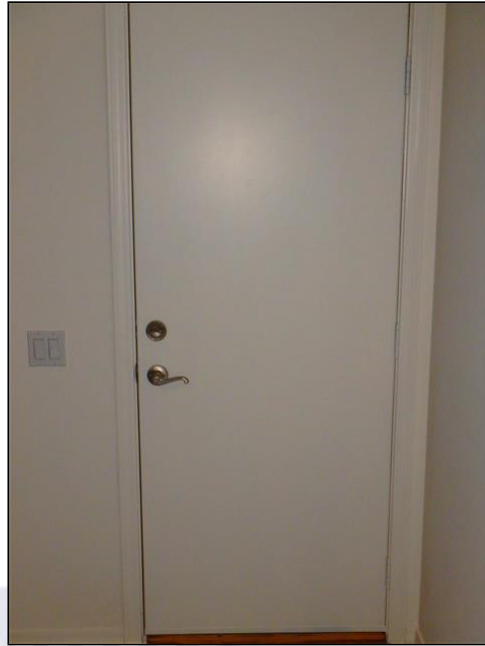
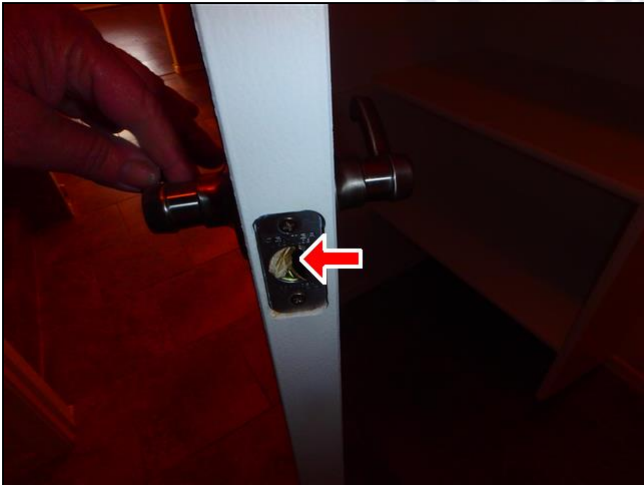
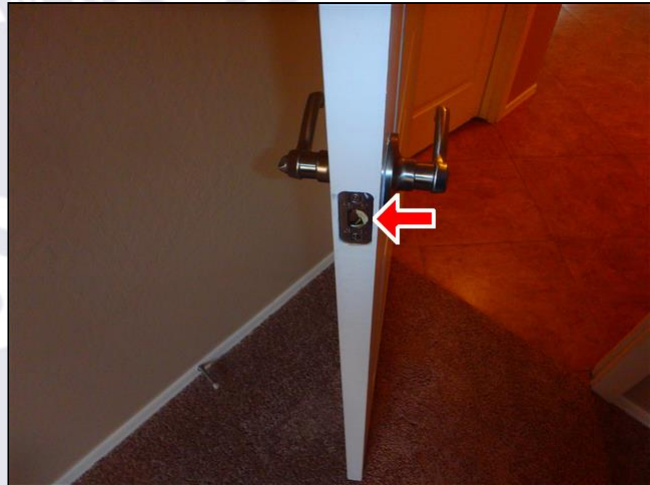
21. (1) Many of the door strikes in the property have tape enabling them from working. Recommend removing tape is necessary.

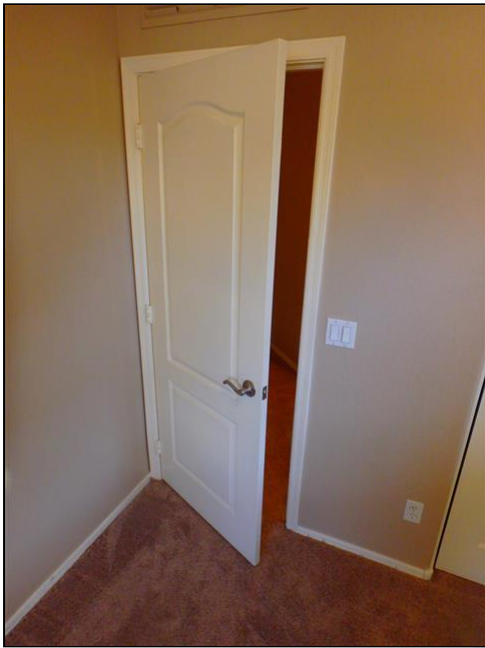
Item 22 - Item 1(Picture) Last bedroom

22. (2) A door at a hall bedroom binds on the jamb. This prevents easy operation of the door. Have a qualified technician adjust the door to restore proper operation.

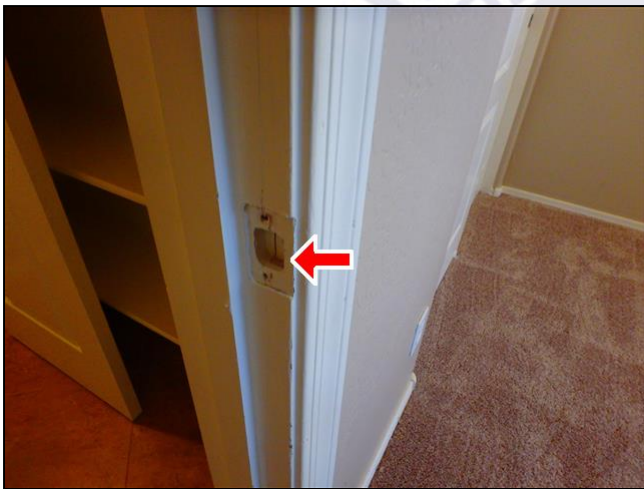
Item 23 - Item 1(Picture) Last bedroom

(3) Door hardware has been removed from a hall bedroom door(s). The door does not function properly. All loose or missing hardware can be repaired or replaced.

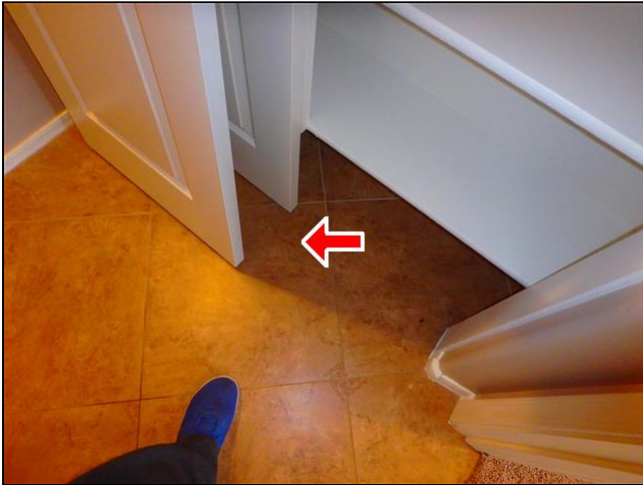
Item 24 - Item 1(Picture)

24. (4) The floor guides to the closet bypass door(s) in a hall closet is missing. The guides should be replaced/installed.

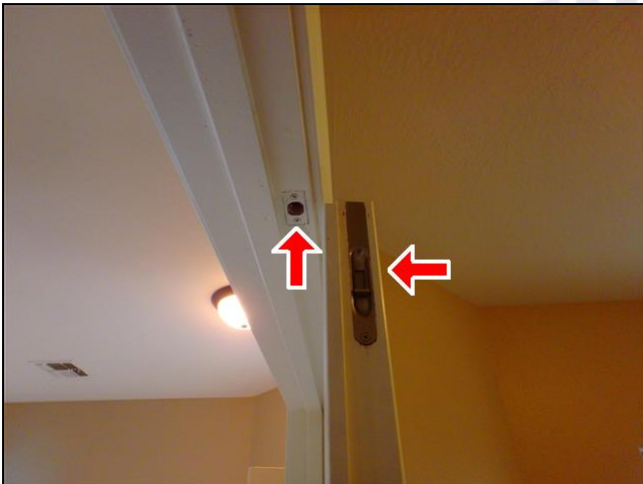
Item 25 - Item 1(Picture)

(5) The drop bolt in the office area is not functional. Recommend further review and repairs necessary by a qualified technician.

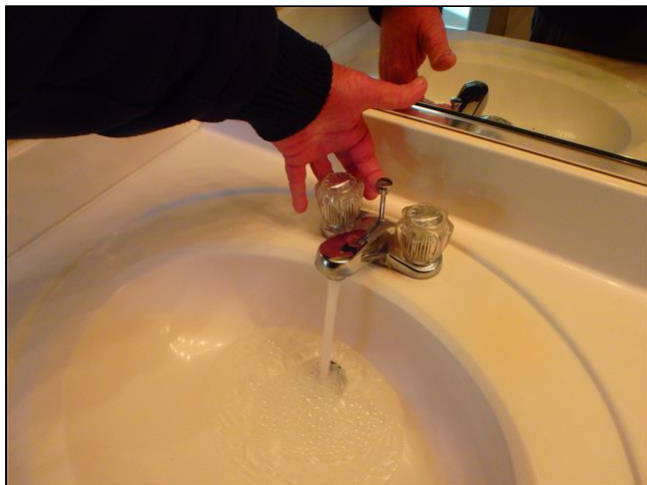
Item 27 - Item 1(Picture) Left side

27. (2) Drain stop(s) that were either missing or not functioning properly were found in the following locations: master bathroom. All drain stops should be functional.

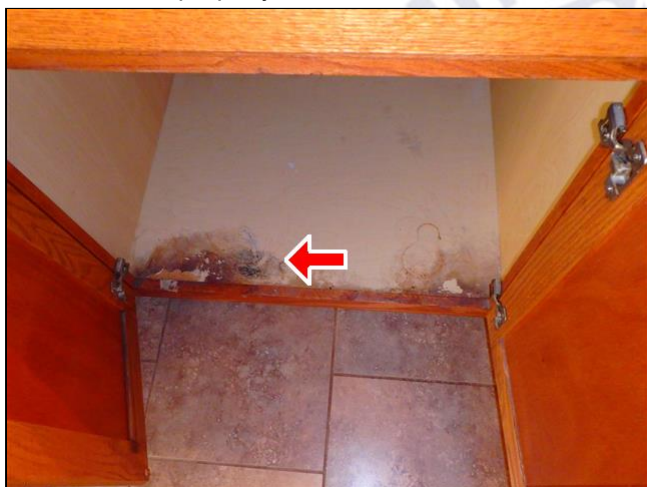
Item 28 - Item 1(Picture)

The floor of the cabinet in the master bathroom is water damaged. All damaged cabinet floors should be replaced with new materials, properly installed. No leaks observed at time of inspection.
