Inspection Report

Down To Earth Inspection

Date: 12/15/2018	Time: 08:00 AM	Report ID: A121418
Property:	Customer:	Real Estate Professional:

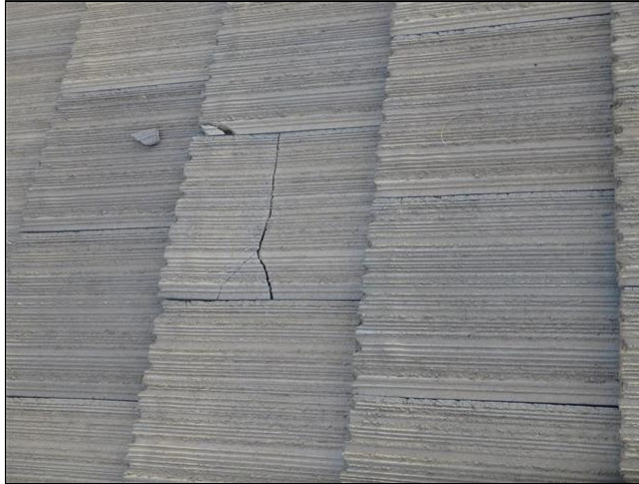
4.1 Item 2(Picture)

4.1 (1) There are broken tiles at various locations leaving the felt underlayment exposed. A qualified roofing contractor should review the roof covers and repair, replace tiles / underlayment as necessary.

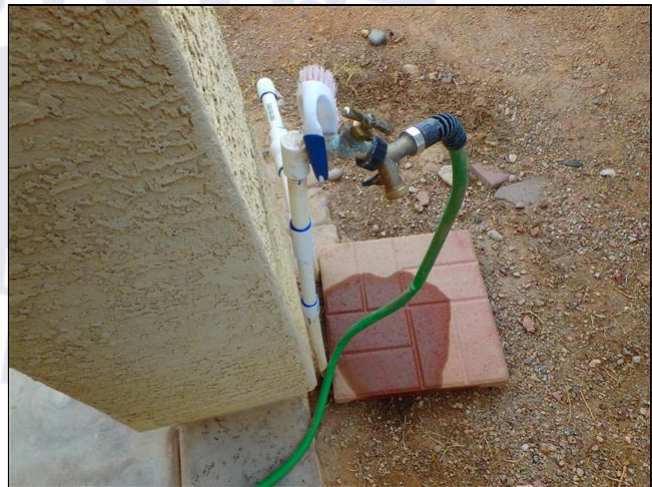
5.2 Item 2(Picture)

5.2 The photos show your shut off devices at the front of the house, and water meter. The meter was moving indicating that a leak in the supply lines is present. We recommend that you have a qualified plumber and or leak detection company review and repair as necessary.

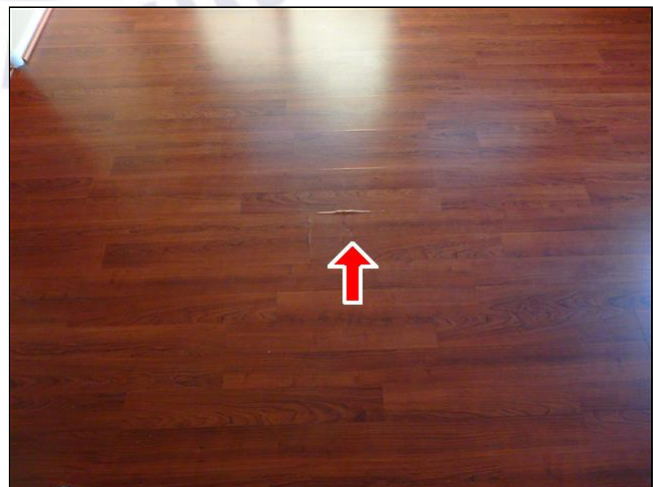
10.3 Item 2(Picture)

10.3 The laminated flooring in the master bedroom is lifting. After further inspection with a moisture meter from the termite company. It was showing on the day of the inspection 100% moisture. As there's typically no Plumbing in the master bedroom floor. In the Plumbing for the property runs through the ceiling this raises a concern. Recommend evaluation by a qualified technician.

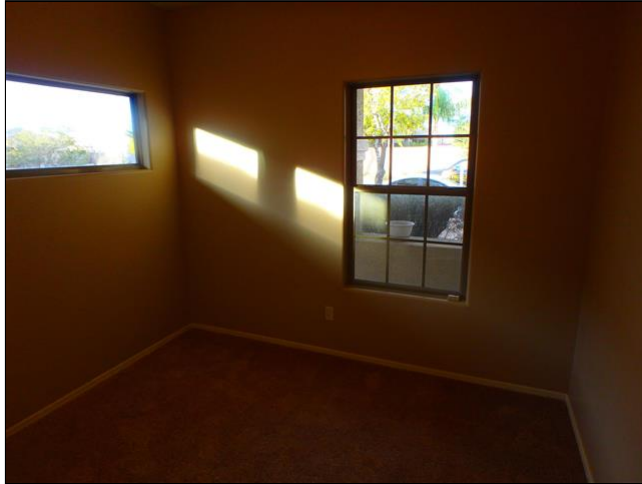
10.4 Item 2(Picture) Last bedroom

10.4 One or more of the windows in a hall bedroom does not operate properly. The counterweight spring mechanisms are damaged.

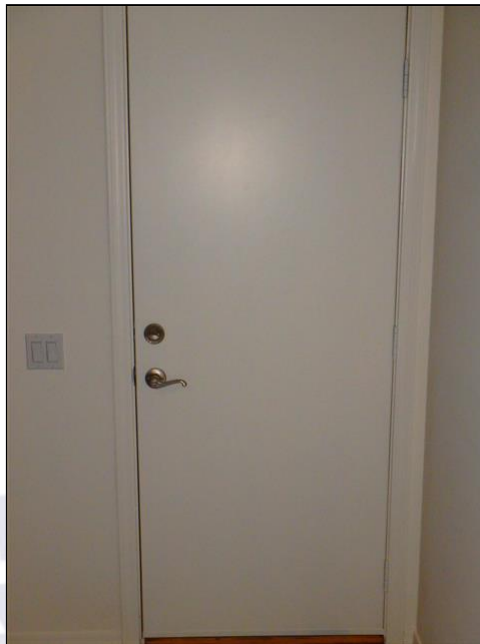
10.5 Item 2(Picture)

10.5 (1) Many of the door strikes in the property have tape enabling them from working. Recommend removing tape is necessary.

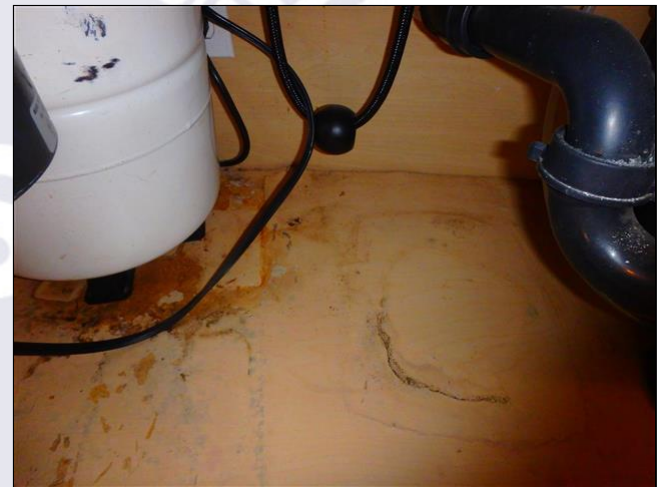
11.3 Item 2(Picture)

11.3 The Cabinet is deteriorated in the area under the sink. Water leakage appears to have promoted decay. Cracked, deteriorated or damaged wood should be replaced.

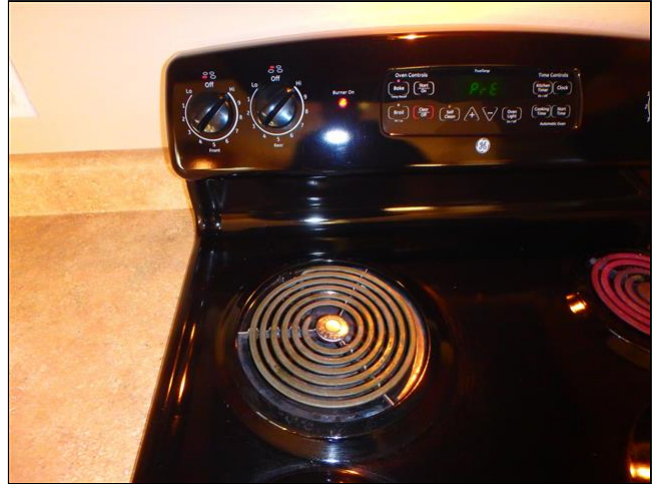
11.4 Item 2(Picture)

11.4 (1) The oven failed to respond to normal operating controls. A qualified appliance technician could make repairs or modifications as necessary.

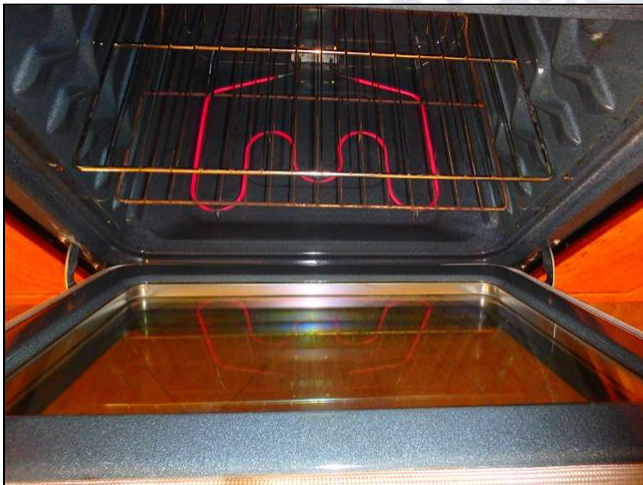
11.4 Item 3(Picture)

11.4 (2) The oven elements operated normally at time of inspection.

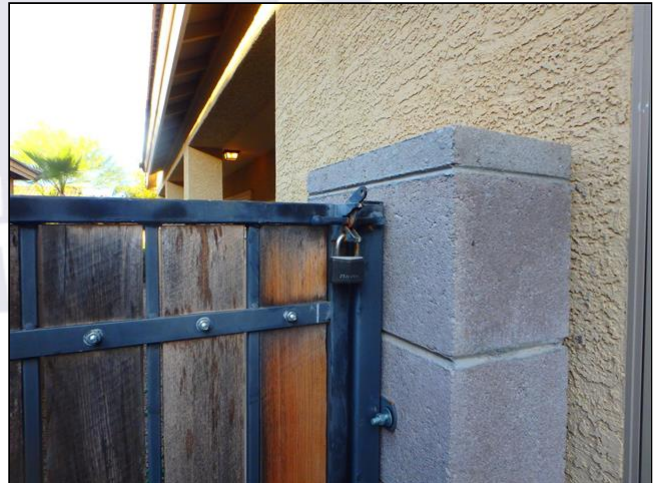
3.4 Item 2(Picture)

The gate at the north elevation and south elevation of the property was locked at the time of this inspection. We could not test the gate. If this gate provides direct access to a pool or spa, it should self close and latch to meet safety requirements. Recommend having the seller demonstrate operation of the gate.

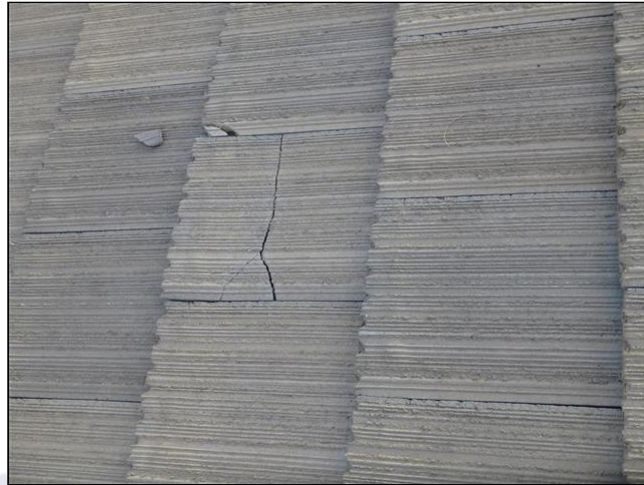
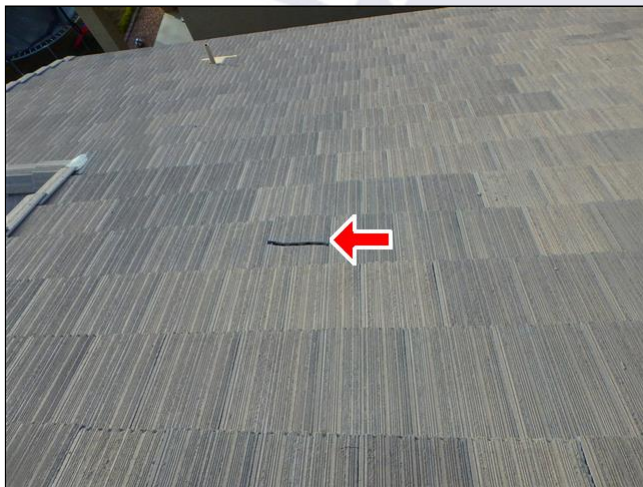
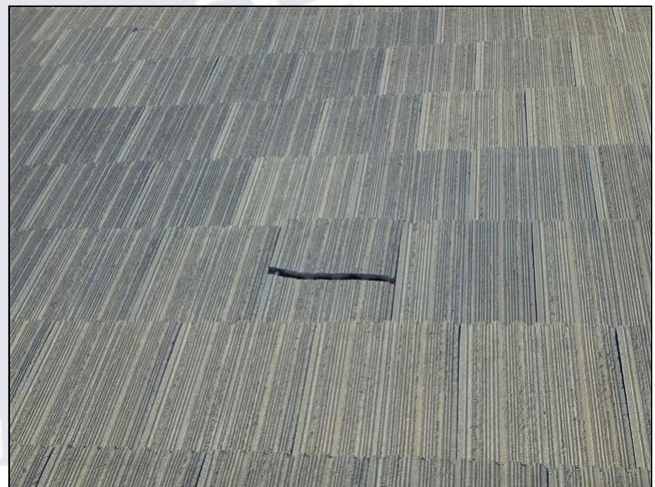
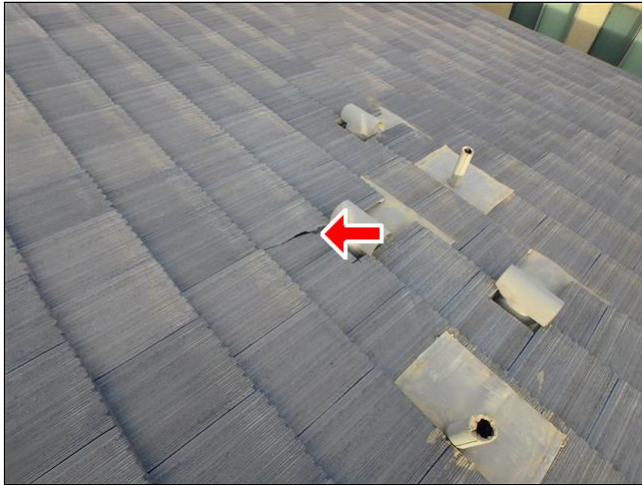
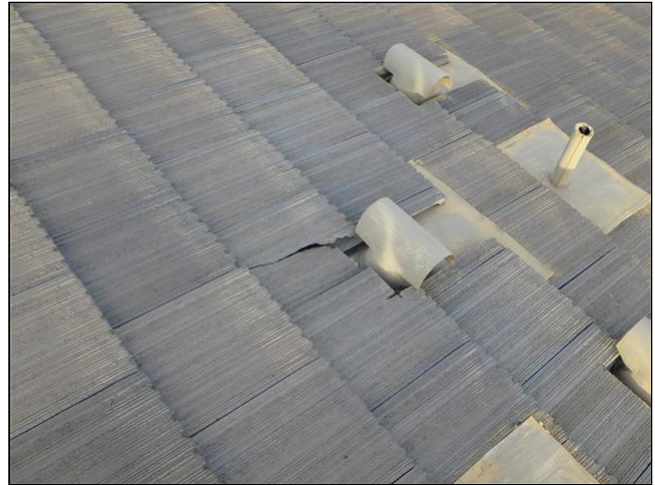
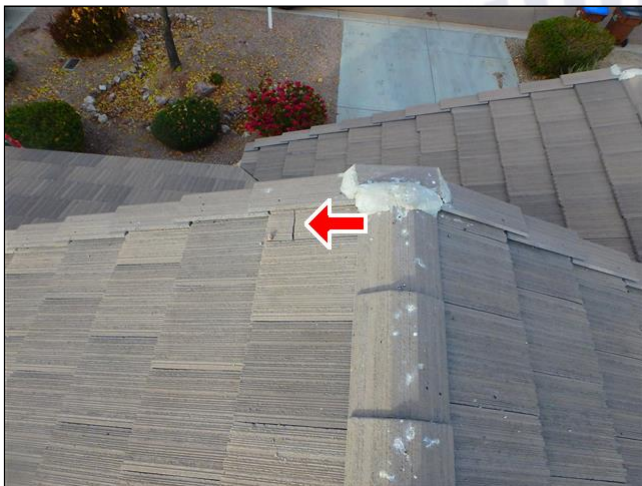
(1) There are broken tiles at various locations leaving the felt underlayment exposed. A qualified roofing contractor should review the roof covers and repair, replace tiles / underlayment as necessary.

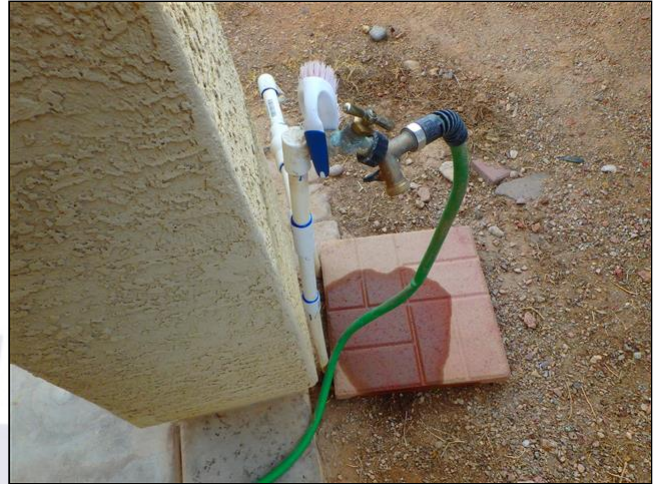
5.2 Item 2(Picture)

The photos show your shut off devices at the front of the house, and water meter. The meter was moving indicating that a leak in the supply lines is present. We recommend that you have a qualified plumber and or leak detection company review and repair as necessary.

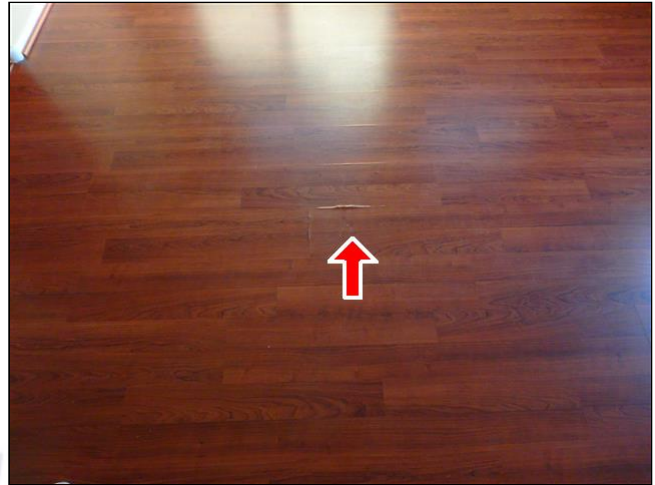
10.3 Item 2(Picture)

The laminated flooring in the master bedroom is lifting. After further inspection with a moisture meter from the termite company. It was showing on the day of the inspection 100% moisture. As there's typically no Plumbing in

the master bedroom floor. In the Plumbing for the property runs through the ceiling this raises a concern. Recommend evaluation by a qualified technician.

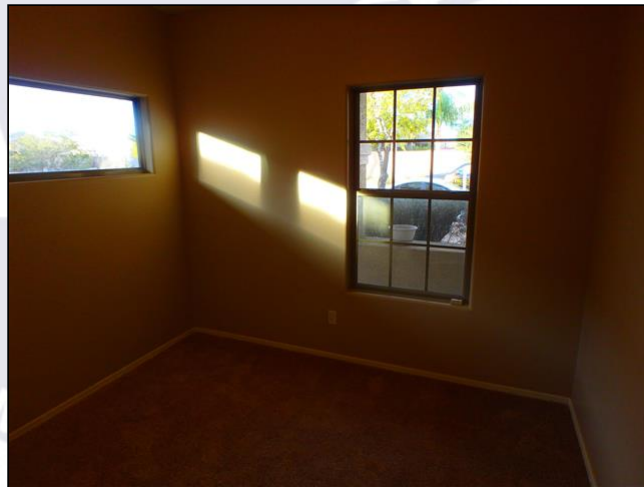
10.4 Item 2(Picture) Last bedroom

One or more of the windows in a hall bedroom does not operate properly. The counterweight spring mechanisms are damaged.

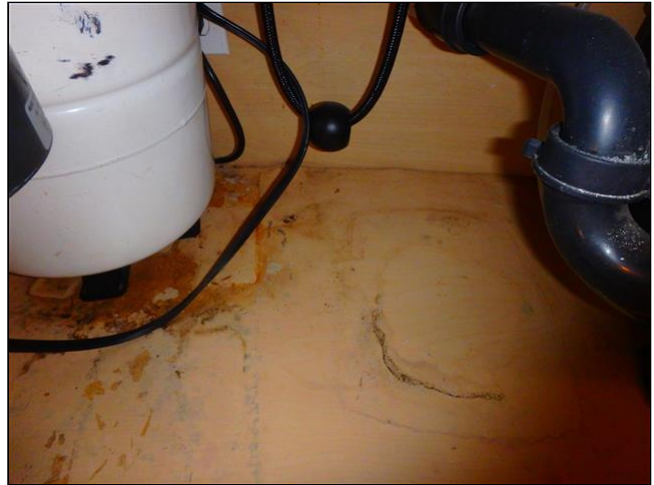
11.3 Item 2(Picture)

The Cabinet is deteriorated in the area under the sink. Water leakage appears to have promoted decay. Cracked, deteriorated or damaged wood should be replaced.

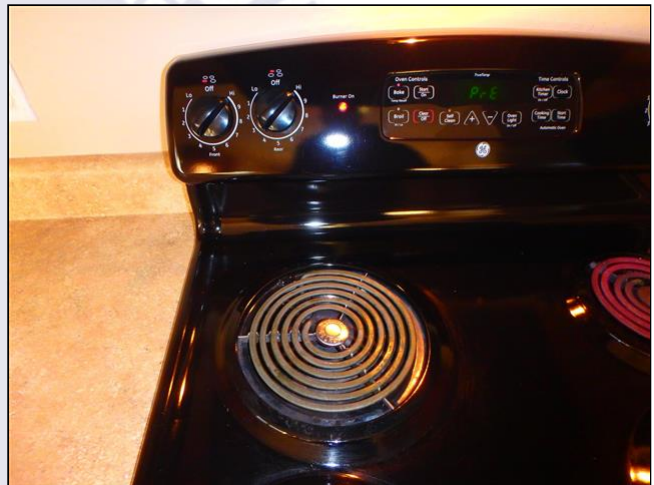
11.4 Item 2(Picture)

(1) The oven failed to respond to normal operating controls. A qualified appliance technician could make repairs or modifications as necessary.

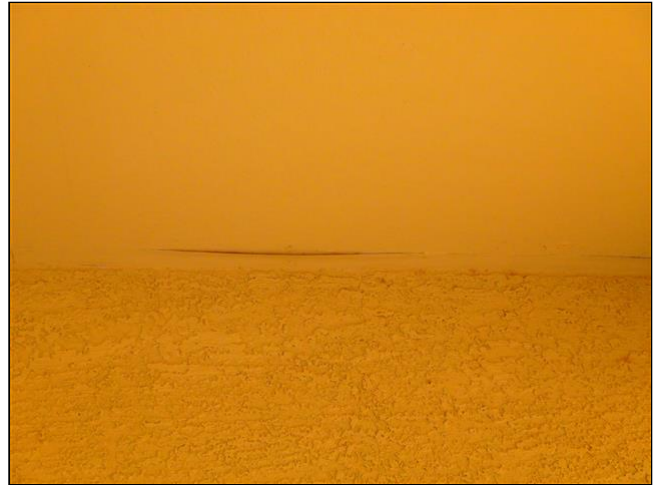
3.2 Item 2(Picture)

The exterior drywall ceiling located at the rear of the property has a bad tape joint. This is common in the state of Arizona and should be repaired and considered a maintenance item buy qualified technician.

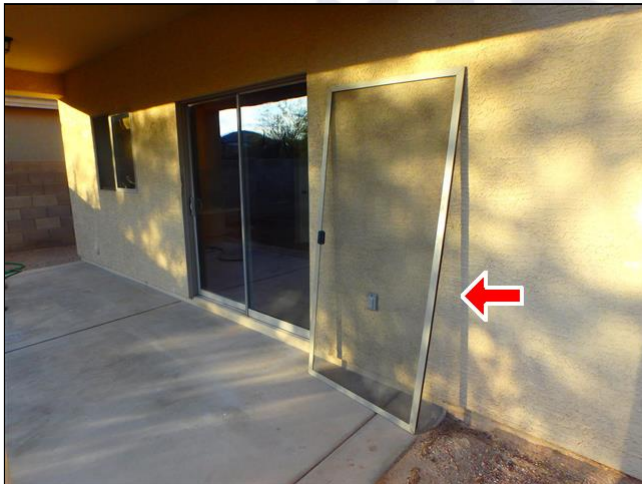
3.7 Item 1(Picture)

The screen door for the sliding glass door at the family room is off the track.

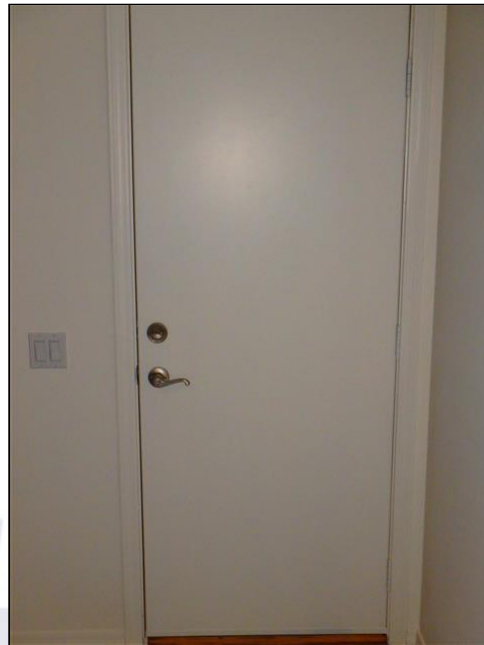
10.5 Item 2(Picture)

(1) Many of the door strikes in the property have tape enabling them from working. Recommend removing tape is necessary.
